Thesis

PhD

Diagnosis and Analysis of Monument Deterioration Classification and Investigation

Study Case: The Medieval Fortifications of Syria/ Crac Des Chevaliers/

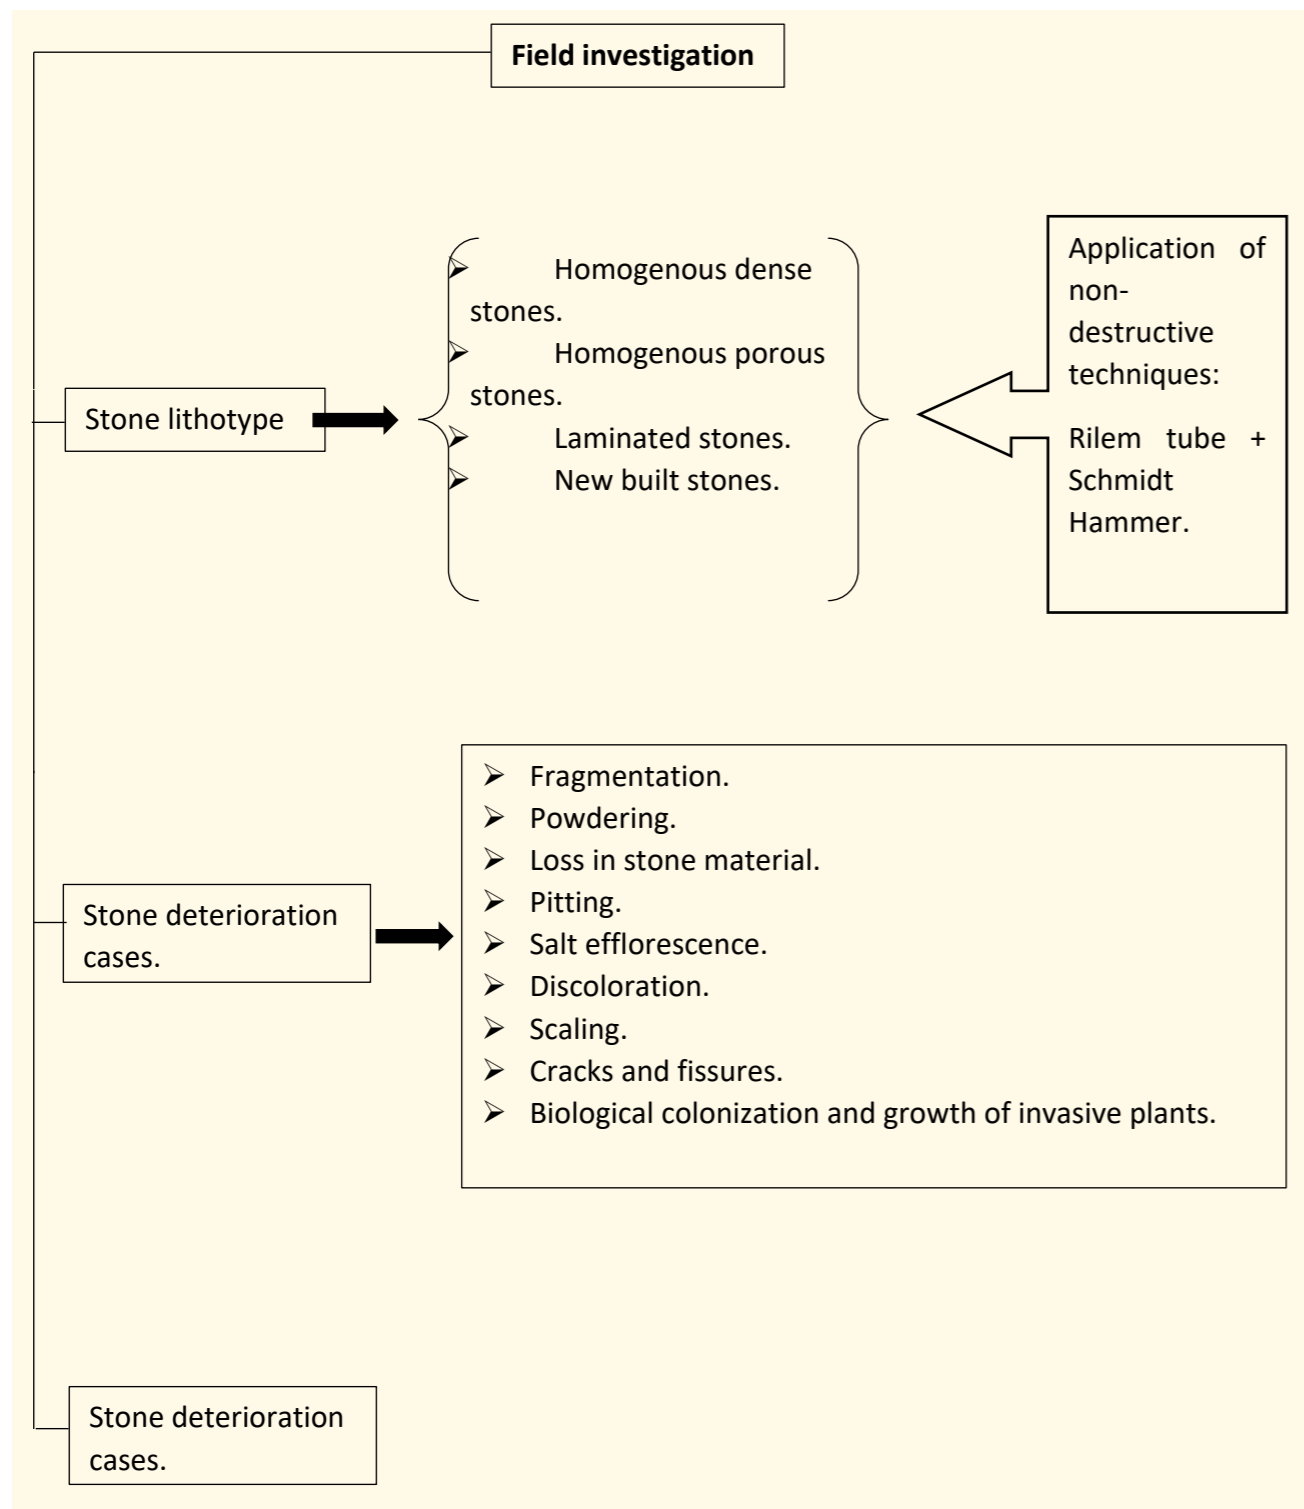
Panel 1 The detailed steps of both field and laboratory investigations that are fulfilled to achieve the objectives of this study

Panel 1 depicts the research plan of this study, which includes two main investigations in-situ and in the laboratory. This research begins with gathering the necessary data about the building site and its conditions, such as meteorological data, climate characteristics, and geological and environmental settings. One of the important data that is investigated is restoration history of the castle. The in-situ and field investigations are divided into several steps. First, the identified stone deterioration cases are classified into various categories [the most serious issues are mechanical (impact) damage, microorganism colonization, salt efflorescence, discoloration, cracks, graffiti, splitting, erosion, and encrustation]. Then, identifying building stone based on the various lithotypes to which it belongs, along with a macroscopic description of those lithotypes. By the naked eye investigation, the castle was built mainly by carbonate stone in addition to the use of basalt stone in some buildings. This study focuses on examining carbonate stones because they are less resistant to weathering than basalt. By the field investigation, the carbonate stones are categorized into four lithotypes as follows: 1)

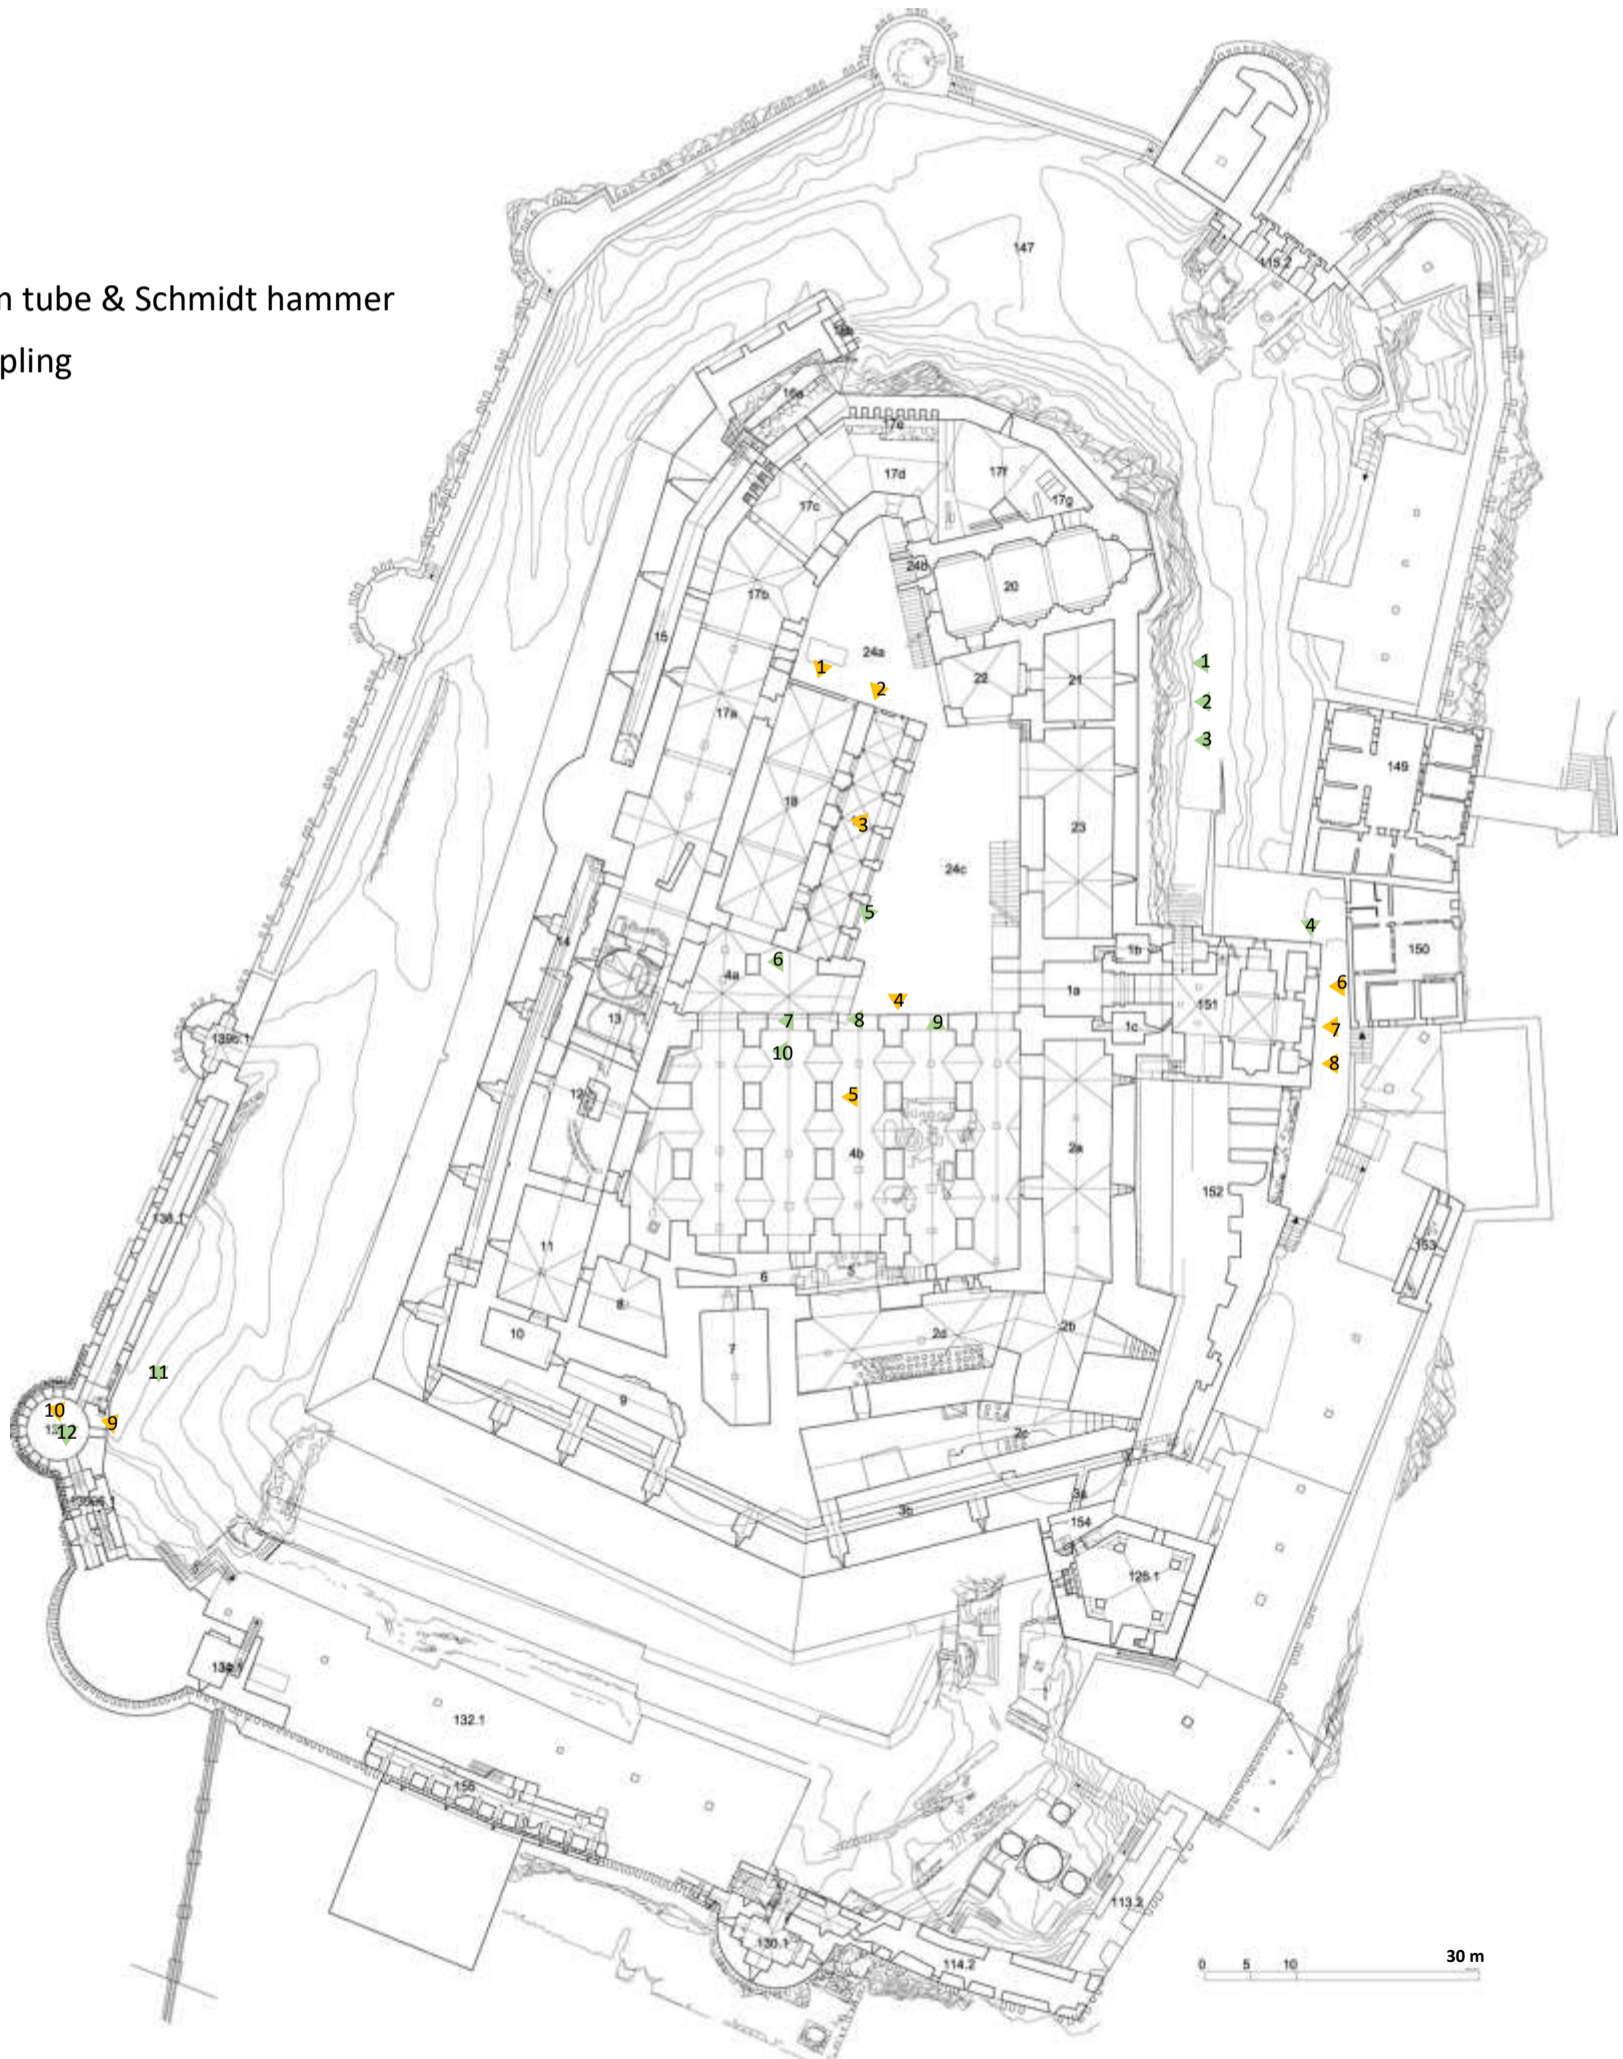
Panel 2 A The locations of the in-situ investigation as well as sampling places-level 3

- ▲ Rilem tube & Schmidt hammer
- ▲ Sampling

Specimen number in the plan	Specimen name	Building period
1	S4	F2 (?)
2	B6	-
3	S5	F2
4	S7	F2
5	S6	F2
6	B3	-

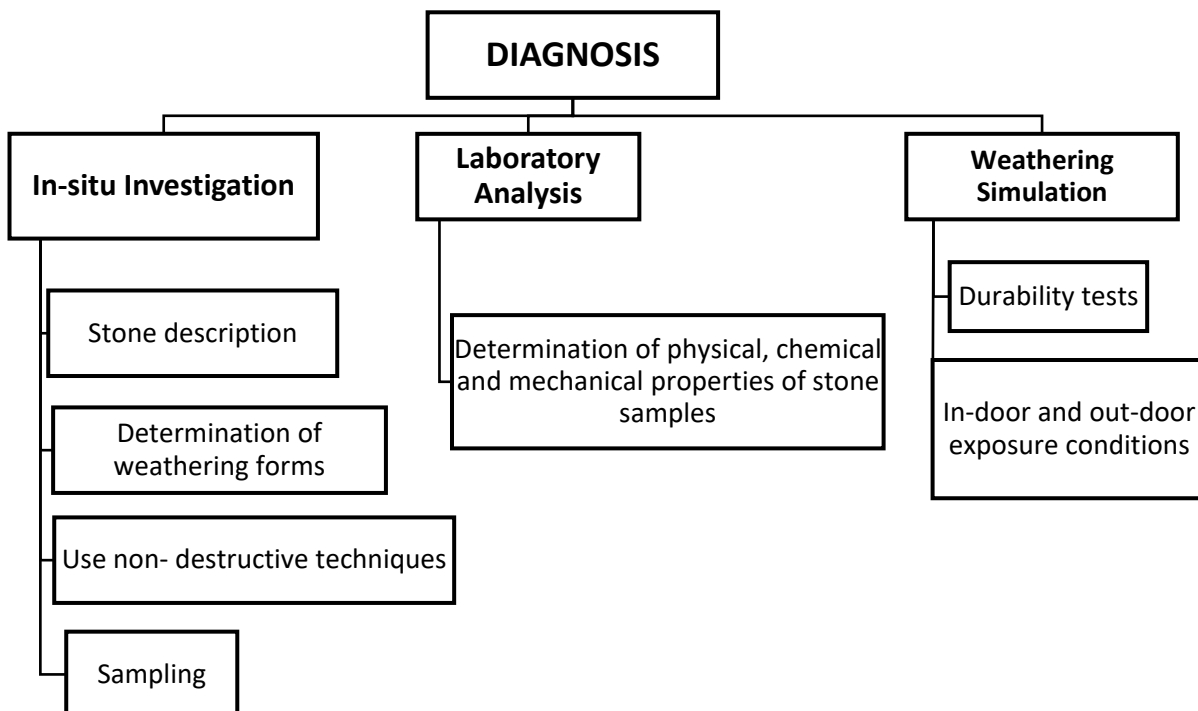
Figure 2. 2 Diagnosis step for the sustainable conservation of historical buildings

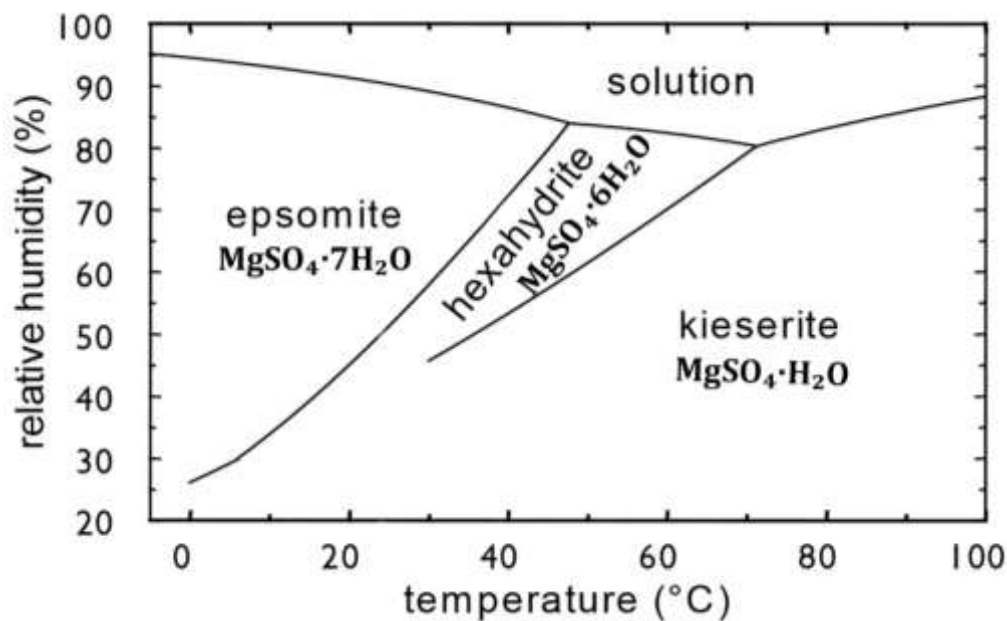
Figure 2. 4 Phase diagram of magnesium sulfate salts as a function of relative humidity and temperature (updated from [Gülker et al. 2007])

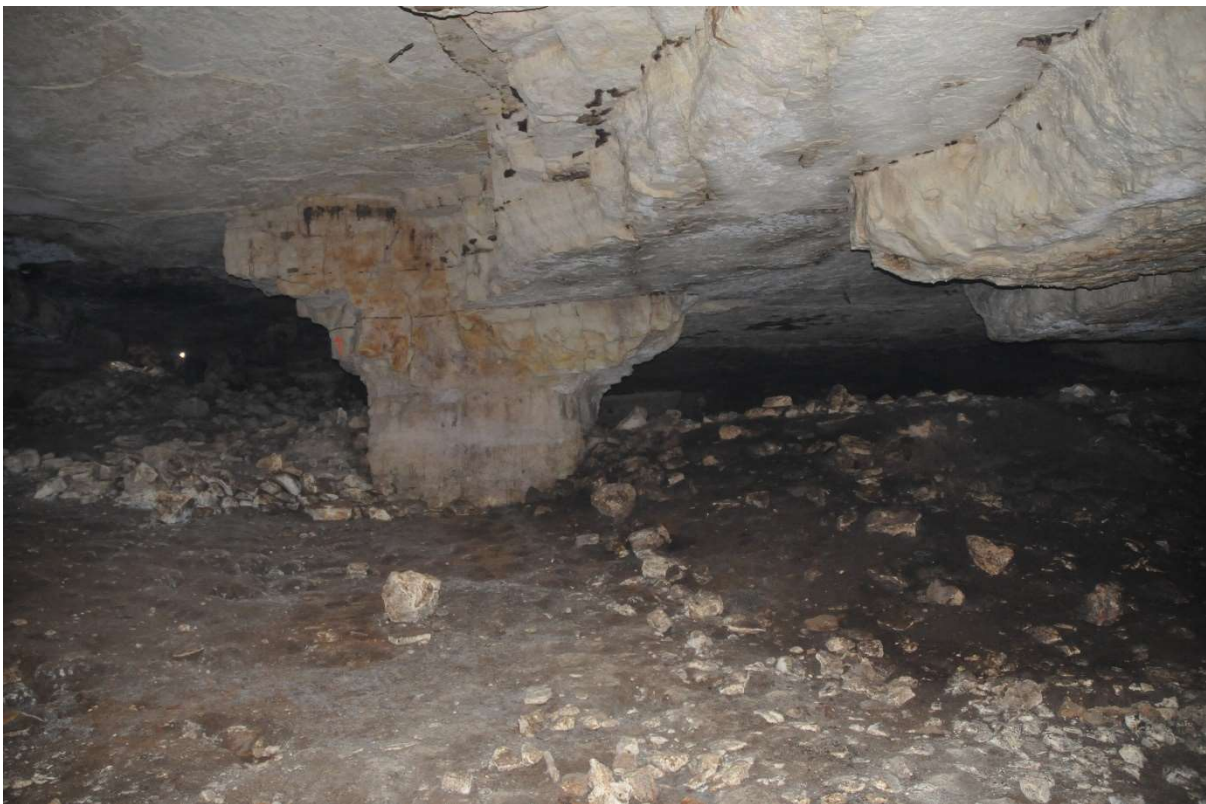
Figure 3. 5 The Magharat Qadda quarry that the Crac stones were brought from. (photo B. Major)

The castle was built from stones that were brought from the nearby quarries in the region. There is one group of quarries 5 km to the west of the site which the literature identified as the main quarrying site for the castle. One of these quarries is Magharat Qadda <sup>221</sup>; which is located in a valley west of the castle, see Figure 3.5.

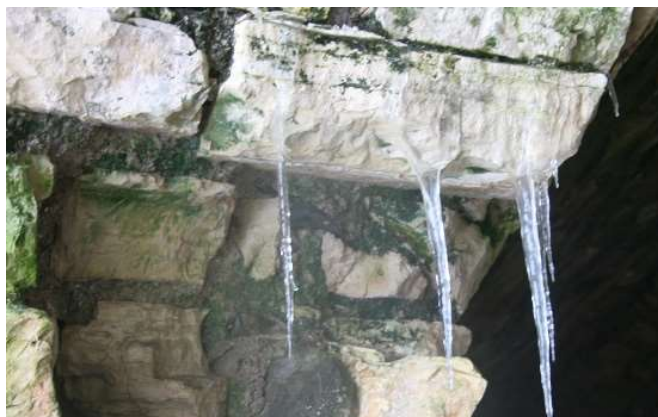
Figure 3. 9 The crystal icicles at the castle, taken in February 2020

Nevertheless, the temperature at this site may drop to a freezing point in wintertime. Consequently, the stones in the castle are exposed to a maximum of one frost-thaw cycle per winter day, and crystal icicles can spawn on the arches in the castle see Figure 3.8 and Figure 3.9.

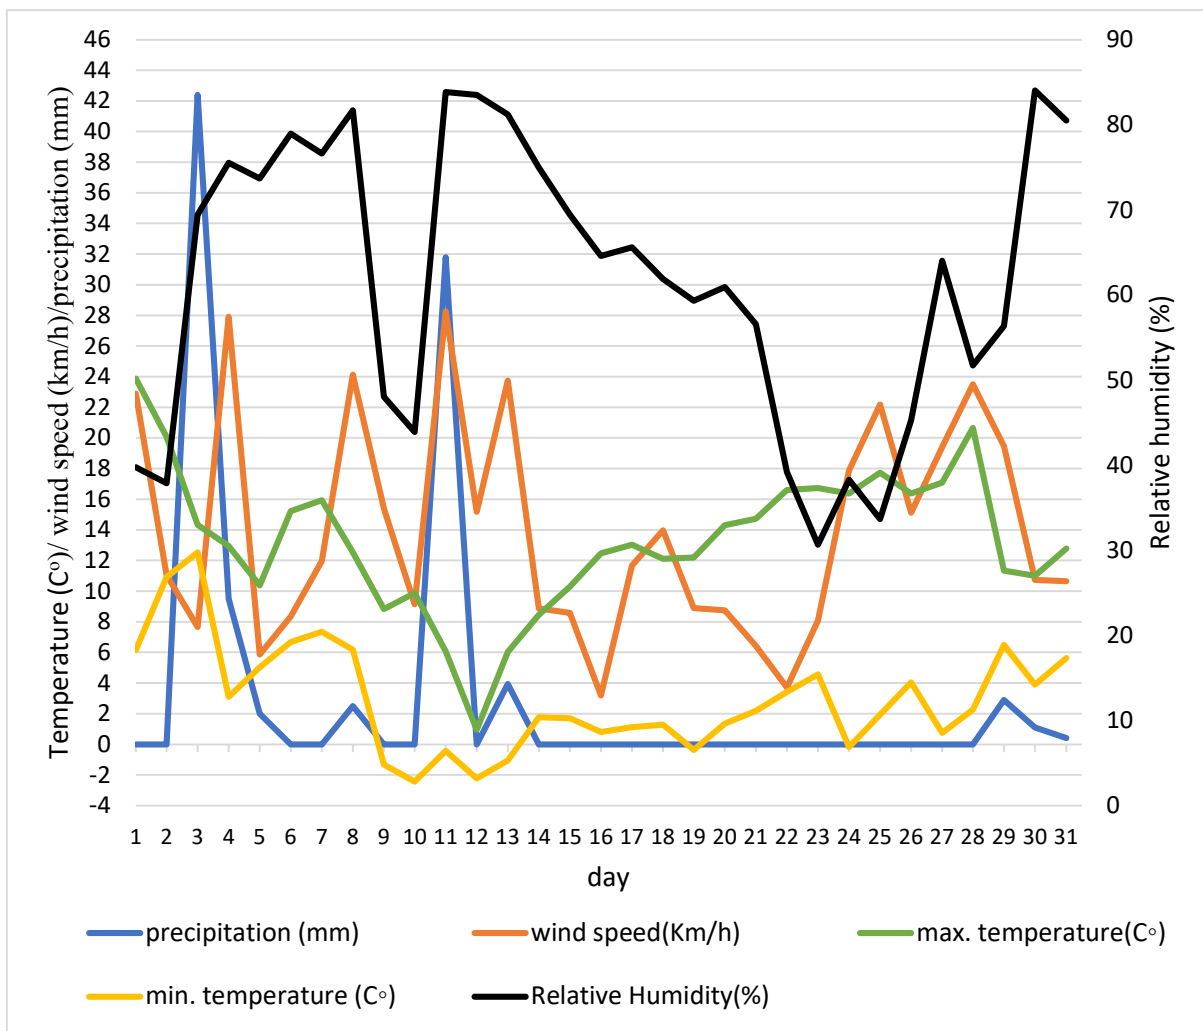
Figure 3. 15 The weather condition at the castle in December 2013. The wind speed values in this chart did not modified according to Equation 3

The observation of the daily minimum temperatures, especially ones below 0°C during the winter months, and the relative humidity underlines the presence of frost in the pores of stones. When the relative humidity value rises, the condensation of water vapor in the pores increases. However, when relative humidity reaches its critical values, the water vapor in the pores will be transformed into liquid water <sup>227</sup>. Therefore, the presence of the liquid water, when the

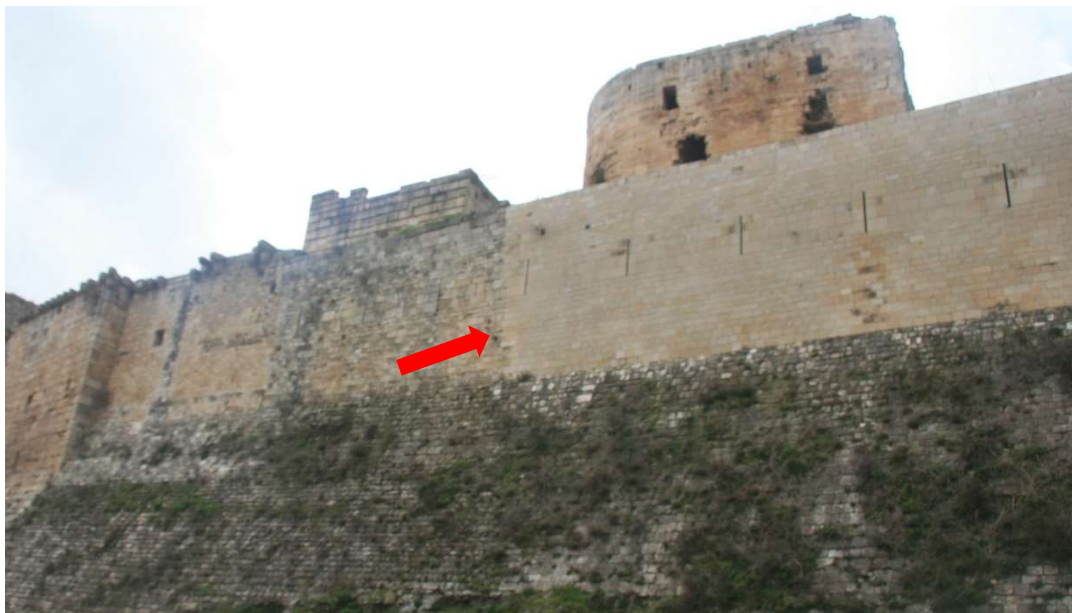
Figure 3. 20 The restoration work of the Building (103) in 2006

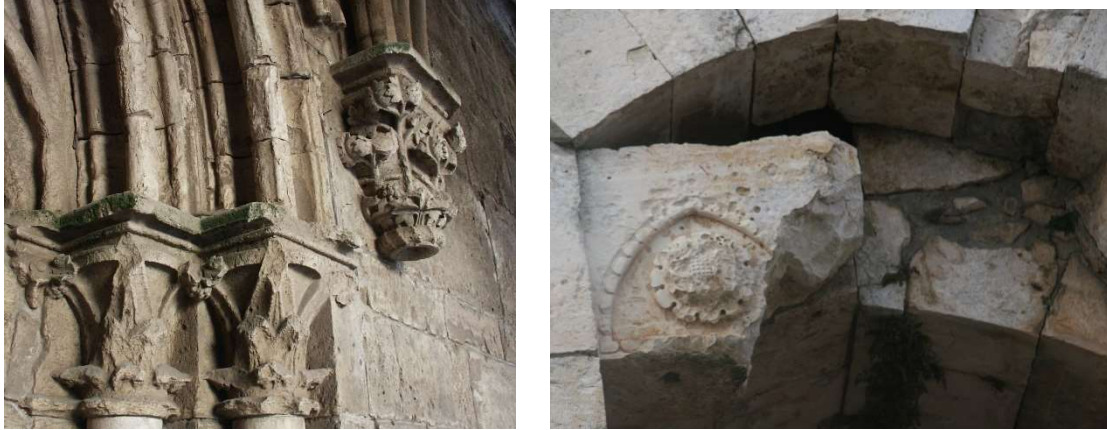
Figure 4.1. 2 Some stone ornaments that are found in the castle

(Figure 4.1.1). As a response to build a prestigious halls containing many types of ornaments, carbonate stones were the best choice to be carved. As a result, the percentage of the carbonate stones used in the building stages of the castle was much more than the basalt stones (Figure 4.1.2).

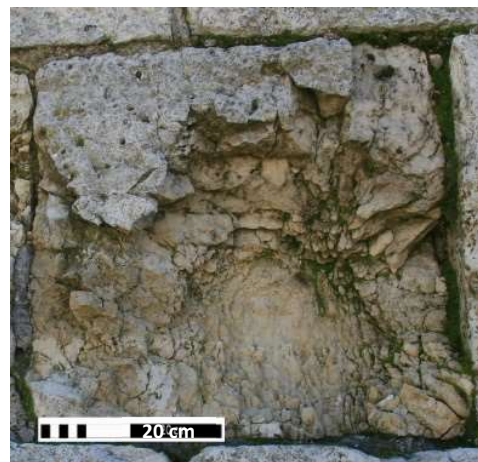
Stone blocks have been damaged as a result of the recent armed conflict in Syria. These stones have varying degrees of destruction. Demolished and fragmented stone blocks (partially or entirely) cannot be restored and must be replaced instead, see Figure 4.2.1 & Appendix 1\_Figure 1. The size of every single fragment from the stone ranges 0.5-10 cm in width and 1-10 cm in depth. However, the direct bullets left powdering areas on the stone surface, see Figure 4.2.2 & Appendix 1\_Figure 2. The diameter of the hole, caused by the bullet, is around 15 cm while its depth is around 5 cm from the stone surface. Missile fragmentation leads to a loss in stone material with a thickness of about 0.5 – 1.5 cm and flaking parts with a thickness ranging from submillimeter to

Figure 4. 2. 1 Fragmentation case

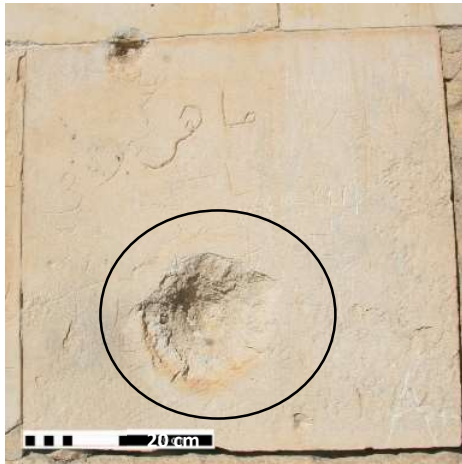
*Figure 4. 2. 2 Powdering case in stone*

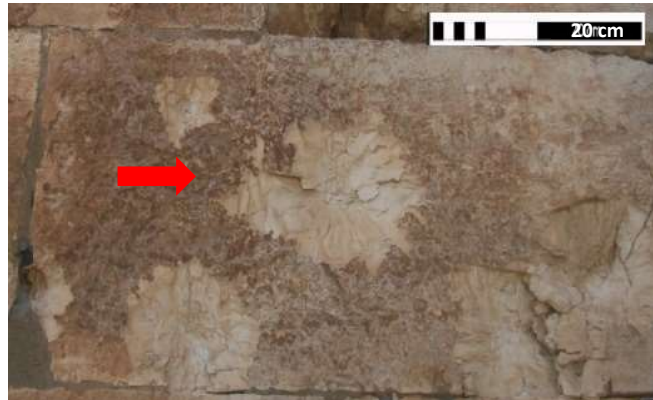
1-5 millimeters (Figure 4.2.3 & Appendix 1\_Figure 3). The stones exposed to direct bullets are still restorable in most cases. The pitted and rough surfaces of the outer façades from the shots represent a favorable environment for the flourishing of various species of microorganism colonization.

*Figure 4. 2. 3 Loss in stone material case in stone exposed to missiles fragmentation*

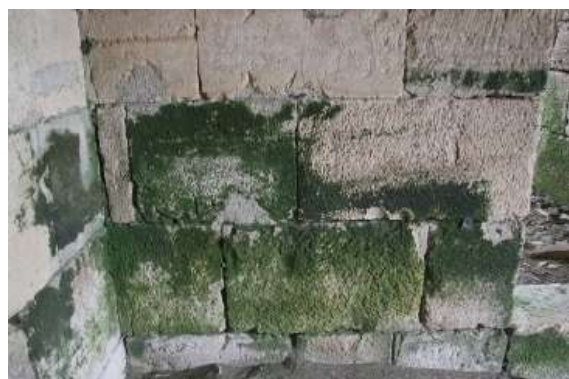
*Figure 4. 2. 4 Green microorganism colonization*

on them. They are also present in south and east façades on shaded areas by plants. The thickness of the colonization is very thin (not visible to the naked eye) in most cases.

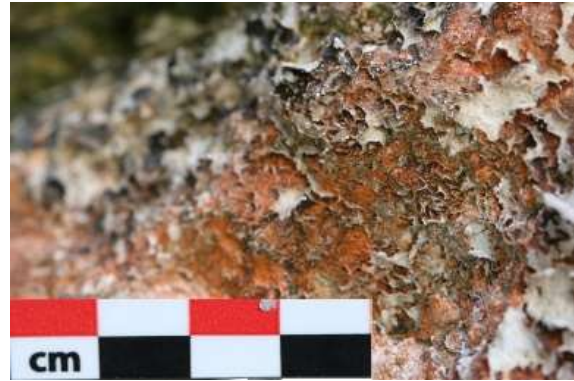
Figure 4. 2. 7 The microorganism colonization on third pillar from west of the first northern row of Pillar of Building (4) (east face)

from the stone surface in some areas, with a small amount of stone material attached to it. (Figure 4.2.7 & Appendix 1\_Figure 8). The second one can be found on the east face of the second pillar from west of the first northern row of Pillar of Building (4) (the same location as the B5 sample, see Appendix 3). That colonization is brown and has the appearance of moistened sand (Figure 4.2.8 & Appendix 1\_Figure 9).

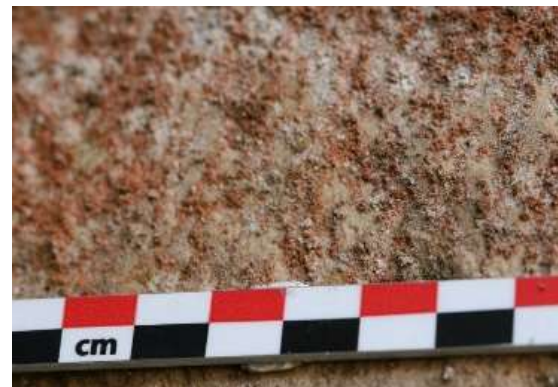
Figure 4. 2. 8 The microorganism colonization on the second pillar from west of the first northern row of Pillar of Building (4) (east face)

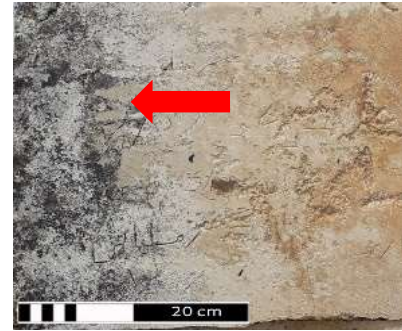
Figure 4. 2. 9 Black and white microorganism colonization on the outermost west edge of the south external façade of Building (46)

Black and white microorganisms flourish on the external southern façade of the Building (46). They vertically grow at the western edge of the façade. They heavily colonize that section in a thickness of around 1-3 mm (Figure 4.2.9 & Appendix 1\_Figure 10).

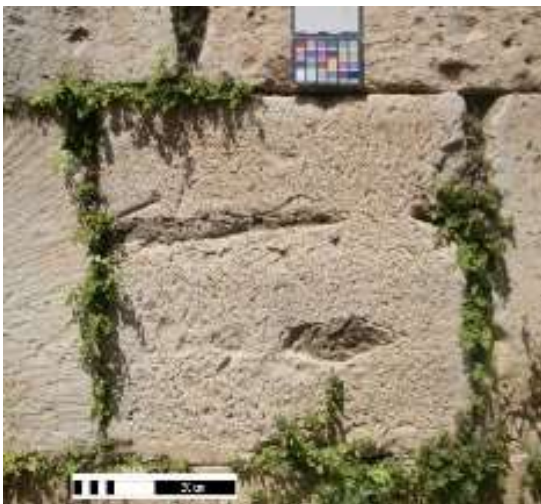
Figure 4. 2. 11 Herbaceous species grow in the joints between the stone blocks

issues that challenge the conservation state of the stones there. The invasive plants include the growth of shrubs and herbaceous species. The shrubs and trees influence the stability of the whole wall and threaten the entire structure of the building (see Figure 4.2.11 & Appendix 1\_Figure 4). The herbaceous

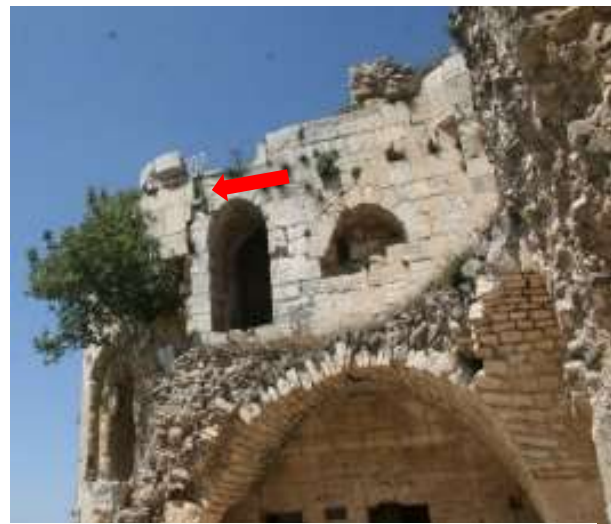
Figure 4. 2. 10 shrub that grows on the east corner of Building (39). The red arrow refers to massive crack caused by the plant

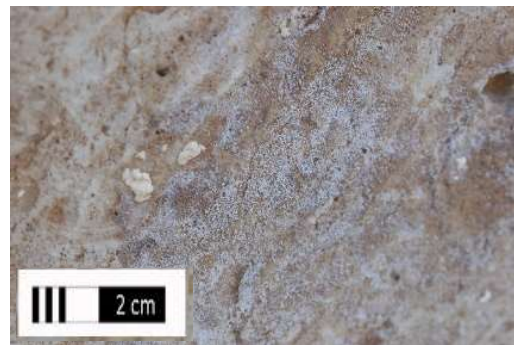
Salt efflorescence and sub-efflorescence are not only presented on the ground floor level because of rising damp but also at the level of the upper floors where that salt appears in light thickness, see Figure 4.2.13 & Appendix 1\_Figure 11. One of the sources of salts is the air-bearing sea salts. The castle is located around 35 km away from the coast.

Figure 4. 2. 14 Salt efflorescence on a stone surface located in the first floor. The salt source is from sea spray effect

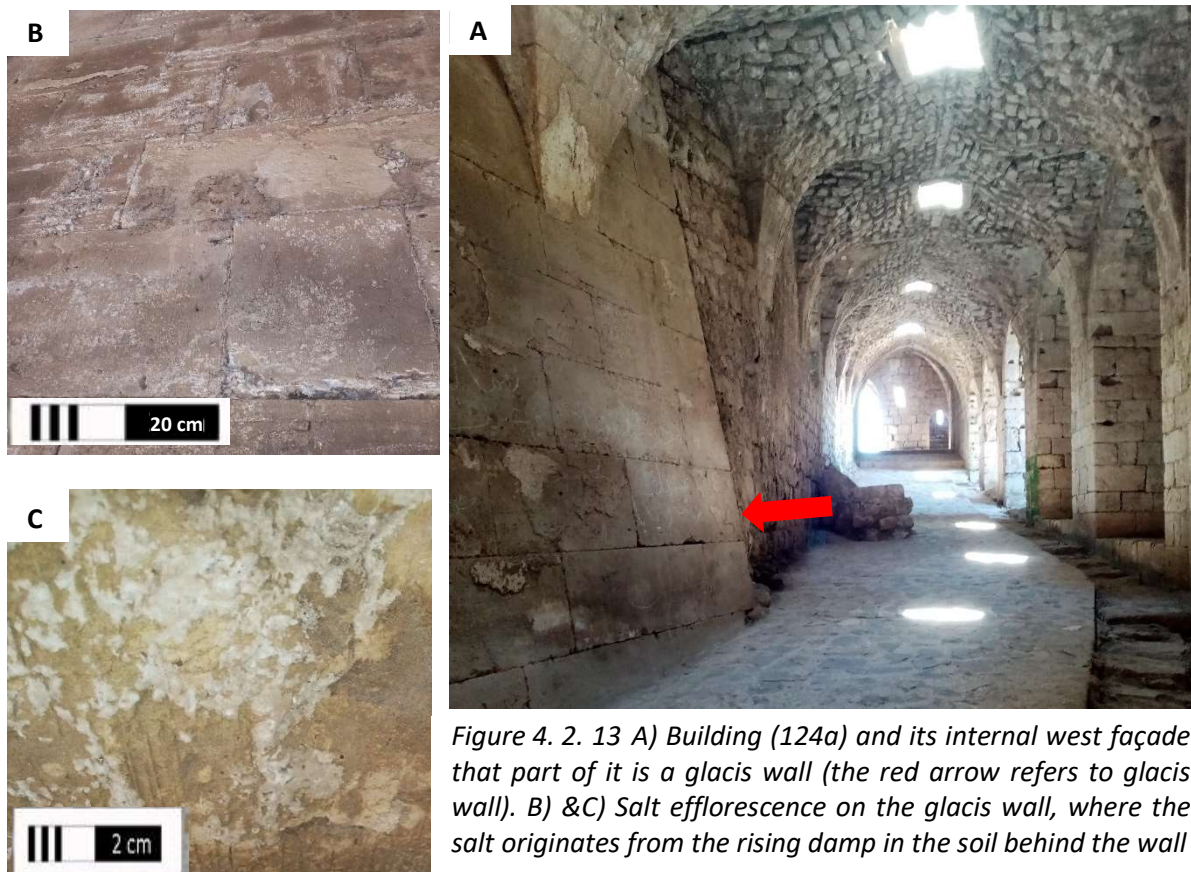
Figure 4. 2. 13 A) Building (124a) and its internal west façade that part of it is a glacis wall (the red arrow refers to glacis wall). B) & C) Salt efflorescence on the glacis wall, where the salt originates from the rising damp in the soil behind the wall

Salts can be seen on the stone surfaces exposed to rising damp from the soil, such as the stones located near the ground or glacis walls that retain soil behind it, such as in Building (124a) (see Figure 4.2.14).

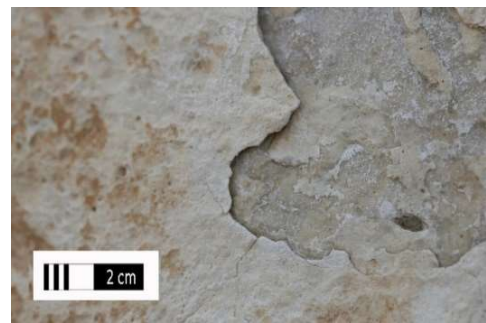
*Figure 4. 2. 15 Discolouration with orange together with scaling part and salt sub-efflorescence*

occurs by scaling with some traces of salt sub-efflorescence in some parts of the stone. The thickness of the exfoliated layer on the stone surface is about 0.5 cm, see Figure 4.2.16 & Appendix 1\_Figure 12.

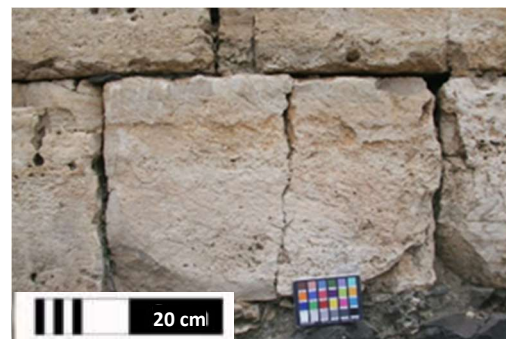
Cracks of different types can be also found at the castle. The first type of crack is a fracture that divides the stone into two parts. The thickness of the fracture ranges from 0-2 cm (Figure 4.2.17 & Appendix 1\_Figure 16).

*Figure 4. 2. 17 A fracture in the middle of the stone*

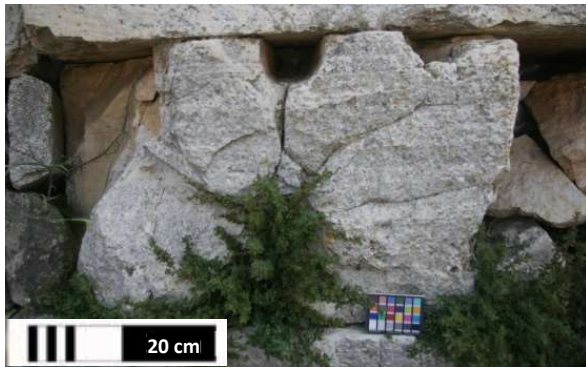
Star crack is a network of cracks that originate from one point. That point is created by mechanical damage that might be resulted from the bombing effect or the growth of higher

Figure 4. 2. 18 A star crack

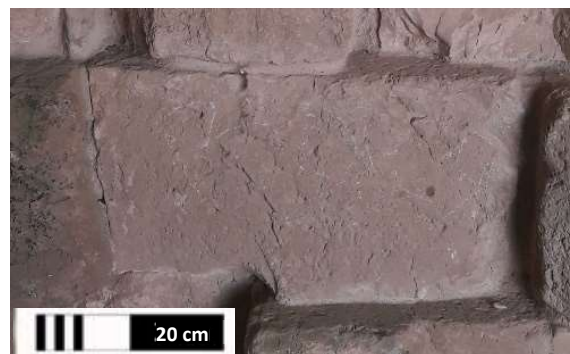
- Building (35) at the castle is characterized by two typical deterioration cases: On the inner façades, all the stones were eroded or eroded and split. The eroded surfaces are smooth, and the stones have rounded corners. The eroded

Figure 4. 2. 21 Eroded surface in Building (35)

stones lost around 1 mm-1 cm from their surface (see Figure 4.2.21 & Appendix 1\_Figure 15). That building also contains stones with splitting parts that are fragmented and weakly attached to the mother stone. The sizes of splitting parts are variable (between 2- 10 cm in depth and 1-15 cm in width).

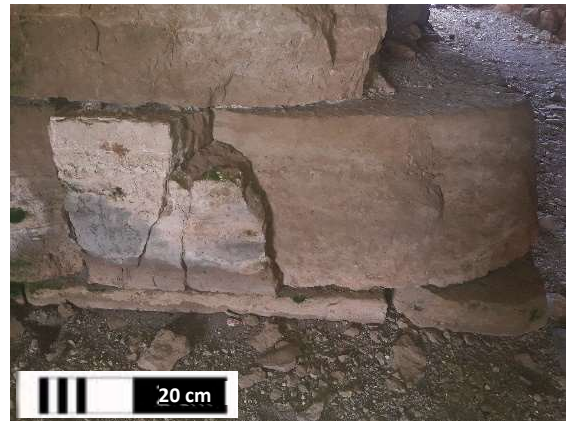
Figure 4. 2. 22 Splitting in Building (35)

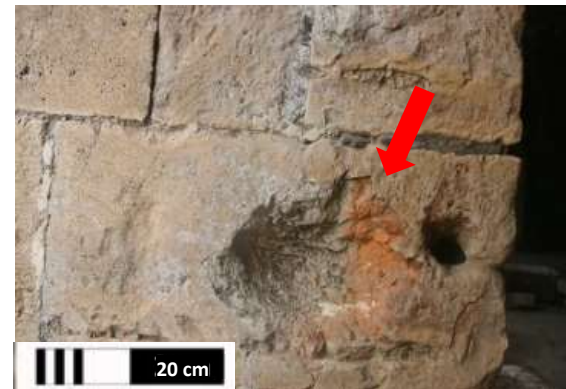
- In both Building (19) and Building (23), some sheltered stones were exposed to bullet or missile fragments. On the damaged areas of these stones an orange material deposits weakly on the stone surface (see, Figure 4.2.23 & Appendix 1\_Figure 21).

Figure 4. 2. 23 Deposition of orange material on the damaged parts by bullet at Building (19)

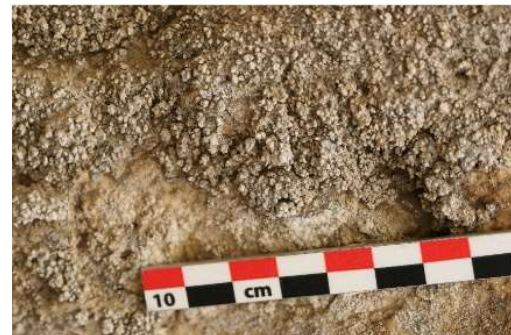
- On the northern and eastern internal façades of Building (38), rounded material deposits heavily on the stone surfaces (encrustation). This framboidal crust adheres to the stone firmly. Each round is 2-5 mm in diameter. (see, Figure 4.2.24 & Appendix 1\_Figure 22).

Figure 4. 2. 24 Framboidal encrustation case in Building (38)

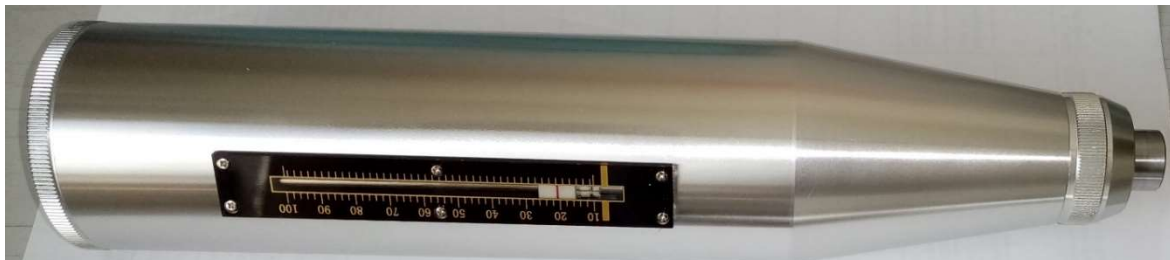
- Impact energy: 0.735 J.
- Rebound hammer stroke: 75 mm.
- Rebound pole: 15 mm.
- Static friction between pointer slider and shaft: 0.4-0.6 N.
- Size:  $\phi$  60\*280 mm.
- Net weight  $\approx$  1 KG.

Figure 4. 3. 4 “VSYIQI” HT-75 brick rebound hammer

In lots of former research works, the Proseq rebound hammer was used. The rebound values of the VSYIQI hammer are compared with the Proseq hammer and converted after drawing the correlation curve between the rebound values of the two hammers. To achieve that, a L- type Proseq hammer and the VSYIQI- HT-75 hammer are used to measure three different strengths (at a steel anvil and on two different limestones (Hungarian travertine from Süttő and Jurassic limestone from Siklós)). The relationship between the rebound value of two hammers is

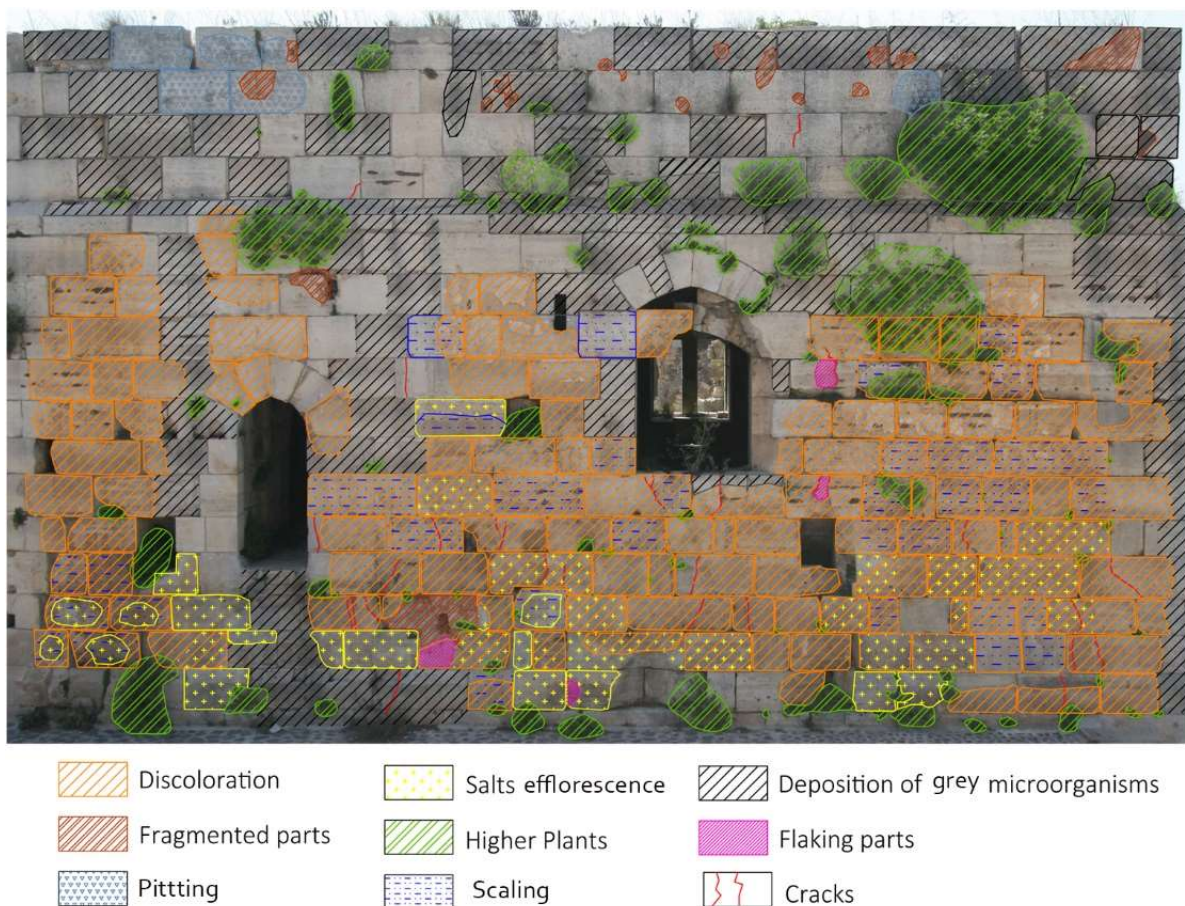
Figure 4. 3. 28 The deterioration mapping of the external east facade of the building (36)

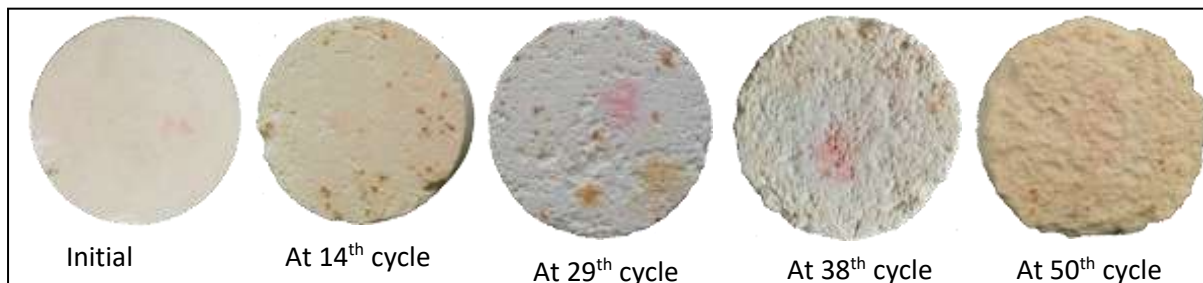
As for S3, and S4, they have similar behaviour where they start to lose their material from the 30<sup>th</sup> cycle, where they lose less than 2 % from their initial masses at the end of the test. S3 starts to lose its material from the 30<sup>th</sup> cycle, but it is a shy loss of around 1 w/w% until the 39<sup>th</sup> cycle. Afterwards, the mass of the specimen gradually decreases until the loss from initial mass reaches 6% at the 50<sup>th</sup> cycle. The ultrasound velocity shows a decrease trend, where the velocity drops from 3.35 km/s at dry phase to 2.5 km/s at the 50<sup>th</sup> cycle. The ultrasound velocity of S3 decreases even though the increase of its mass that indicates cracks propagation inside the stone structure. In addition, the surface of this specimen erodes in the form of pitting that progressively develops during the experiment (see Figure 5.2.36).

*Figure 5. 2. 36 S3 specimen under sodium chloride salt solution*

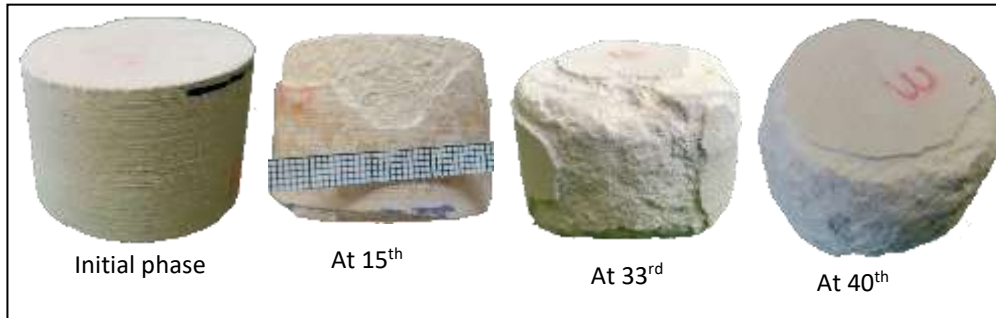
The mass of S3 slightly increases up to the 11<sup>th</sup> cycle, and then the mass dramatically decreases until it reaches 26 % from its initial mass at the end of the experiment (see Figure 5.2.47). This specimen starts to lose its material by making irregular shapes on the stone surface with low percentage mass loss until the 12<sup>th</sup> cycle. From the 12<sup>th</sup> cycle upward, very thin layers from the surface start to detach from the specimen until the specimen has uniform surface, see Figure 5.2.49. The ultrasound velocity of the specimen exhibits an increased trend. The velocity slightly rises, even though the material loss, from 2.2 (at dry phase) to 3.49 km/s (at the 40<sup>th</sup> cycle), see Figure 5.2.48. The salt crystals inside its pores reduce the porosity of the specimen and increase its density, which leads to an increasing velocity. S7 gains mass until 15<sup>th</sup> cycle where its mass increased around 6 % from its initial mass. After that, the surface of

the specimen starts to weather as a form of exfoliation, and the specimen progressively begins to lose its material as a result. By the end of the 40<sup>th</sup> cycle, the specimen loses around 18 % from its initial mass, see Figure 5.2.47. The ultrasound velocity of this specimen also exhibits increase trend even though the material loss from 3.1 km/s (at dry phase) to 4.1 km/s (at the 40<sup>th</sup> cycle), see Figure 5.2.48.

*Figure 5. 2. 49 S3 specimen under magnesium sulfate salt solution*

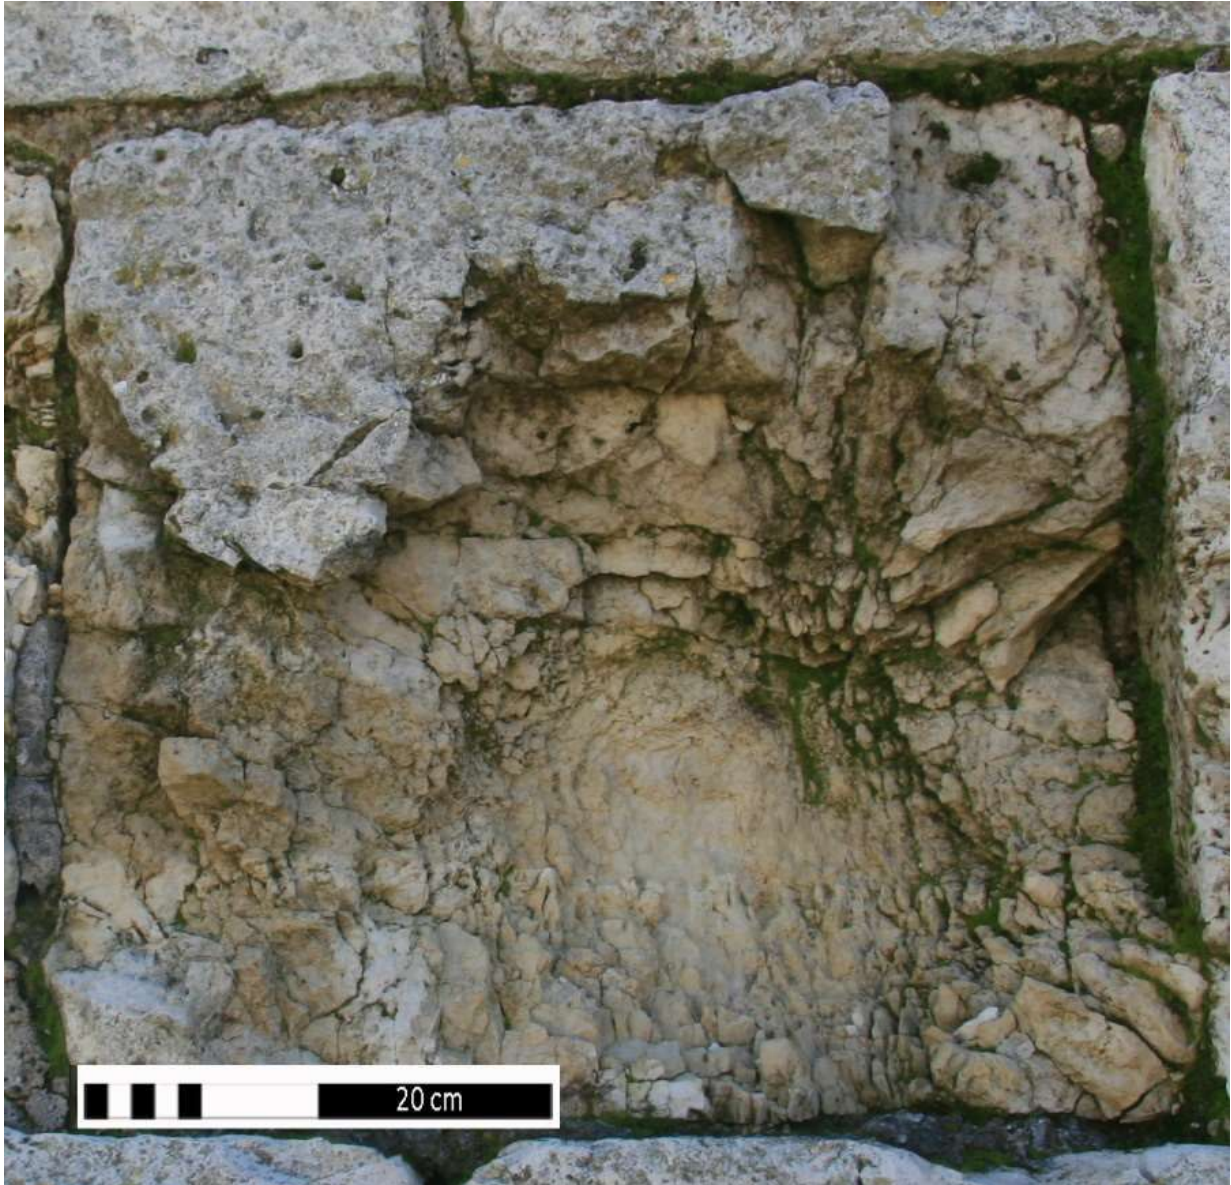
Figure 1

**Fragmentation:**

- There are types of fragmented stones, either the stone entirely or partially fragmented.
- The fragmentation is caused by the shots.
- The size of each single fragment from the stone ranges [0.5-10 cm (width) and 1-10cm (depth)].
