Thesis

PhD

Diagnosis and Analysis of Monument Deterioration Classification and Investigation

Study Case: The Medieval Fortifications of Syria/ Crac Des Chevaliers/

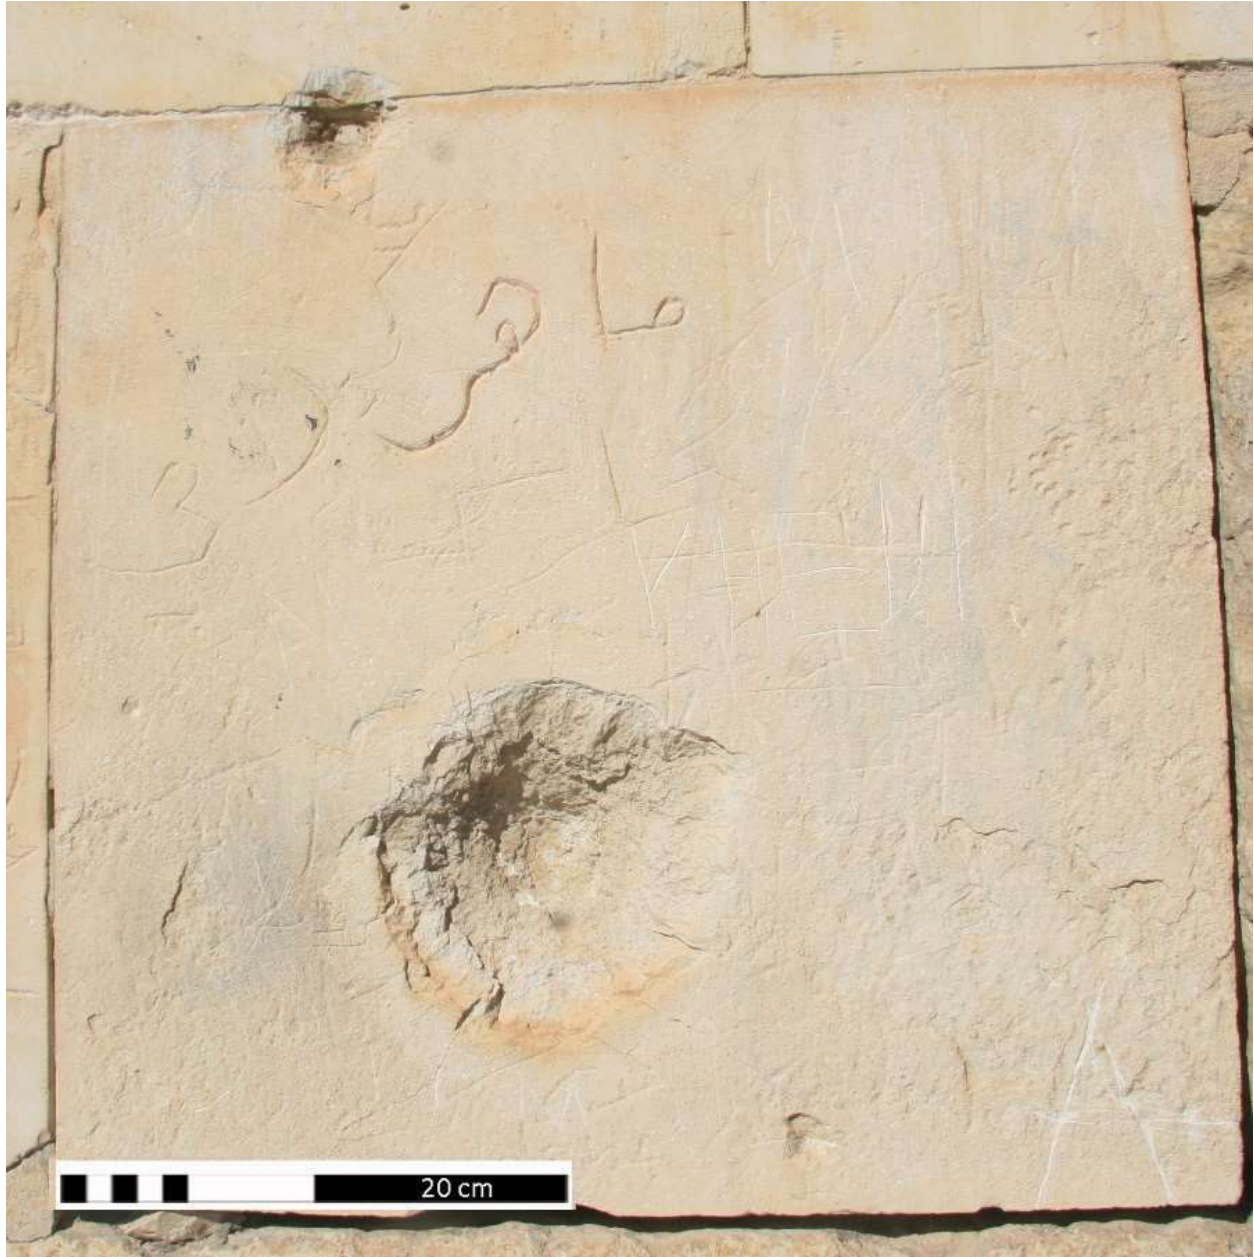
Figure 2

**Powdering:**

- It mainly exists in stones exposed to a direct bullet at the castle.
- The diameter of the hole, which caused by the bullet, is around 15 cm while its depth around 5 cm from the stone surface.

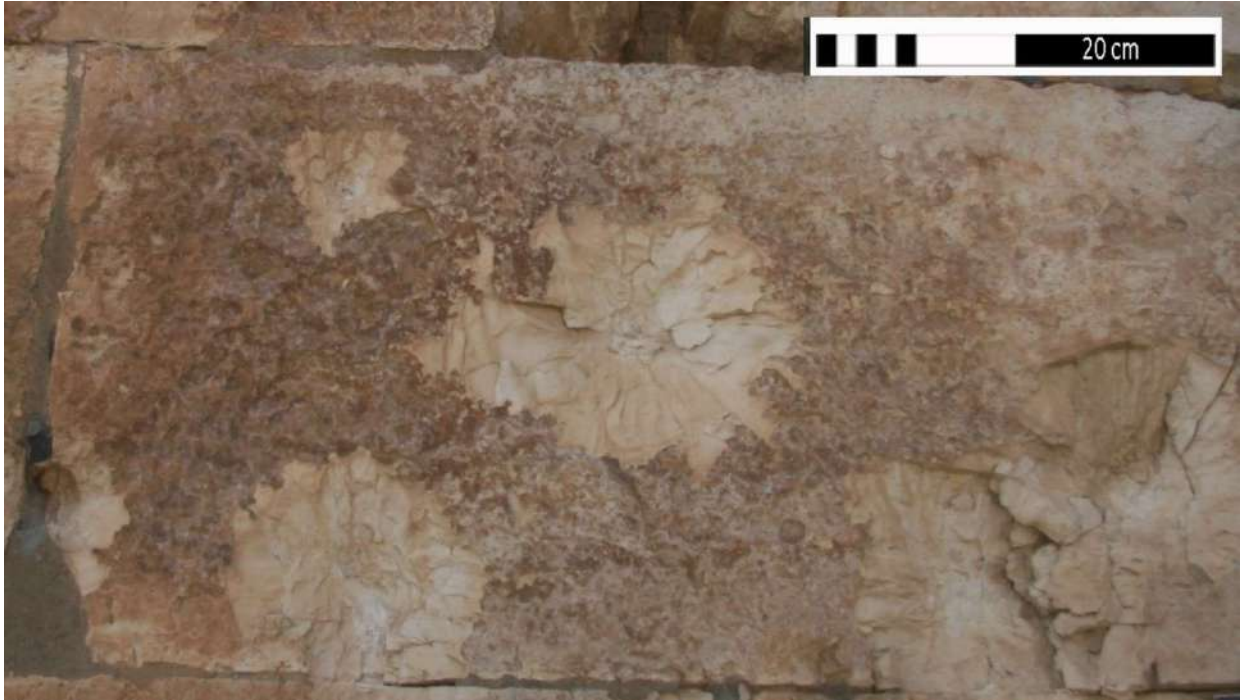
**Figure 3**

**Loss in stone material**

- It mainly exists in stones exposed missiles fragmentation.
- The thickness of the lost material ranges (0.5 – 1.5 cm.).

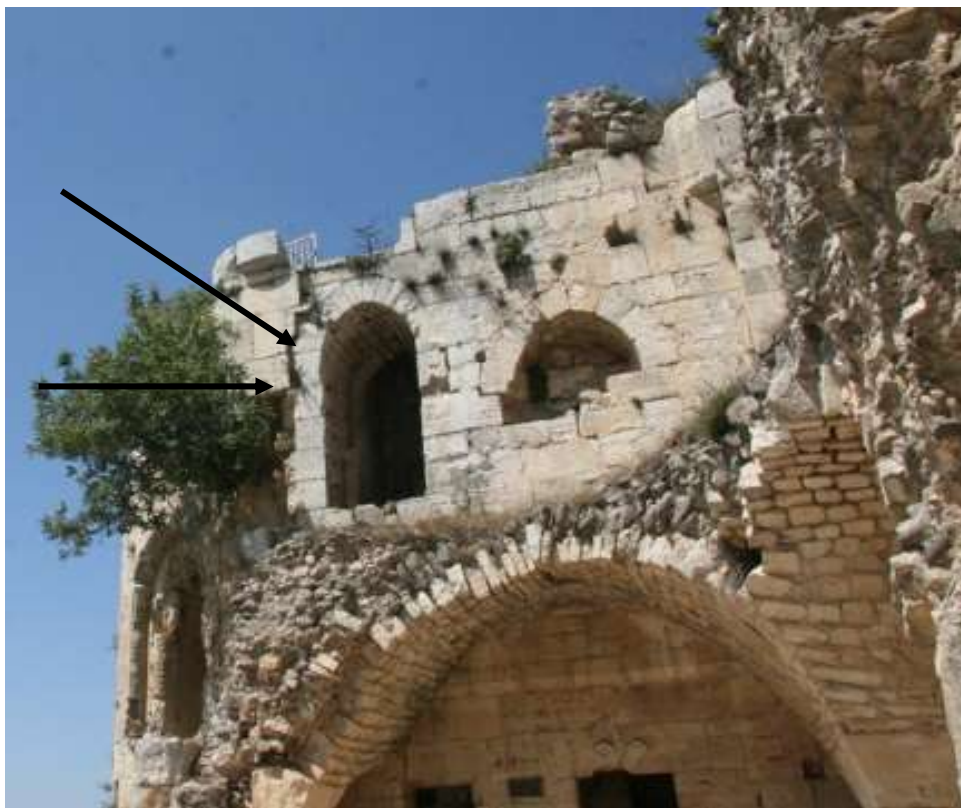
**Higher plants:**

- Two major types of higher plants that are growing on the castle walls are the shrubs and herbaceous species.
- The herbaceous species can be found either between stone joints, where the mortar was lost or inside the cracks of the stone.
- The shrubs invade some walls at the castle. They grow strongly and threaten the stability of the wall. The black arrows, in the photo, refer to a huge crack in the wall.

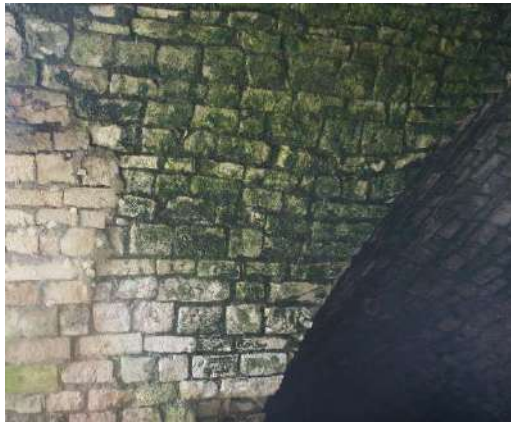
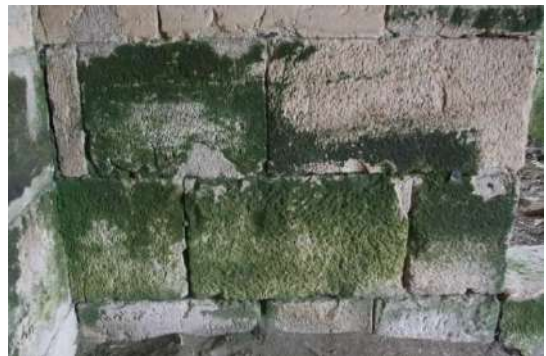
Figure 6

**Green algae colonization:**

- They flourish at indoor stones, which are damped enough by either water infiltration or rising damp from the ground.
- They also colonize the outdoor stones which affected by bullets and missiles fragmentations (specifically in the powdering or fragmented area).
- They appear on the stone surface in variable thickness which ranges from a moisturized green layer with no thickness, to a 1 cm thick layer in some stones.

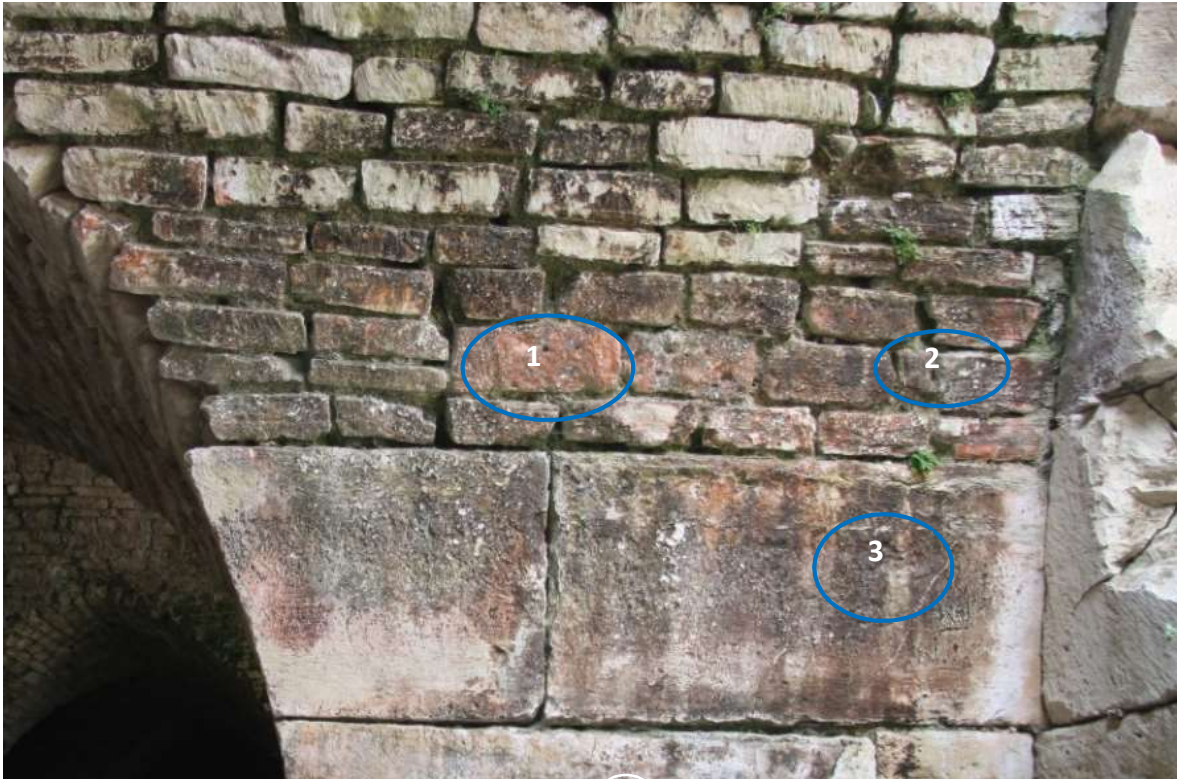
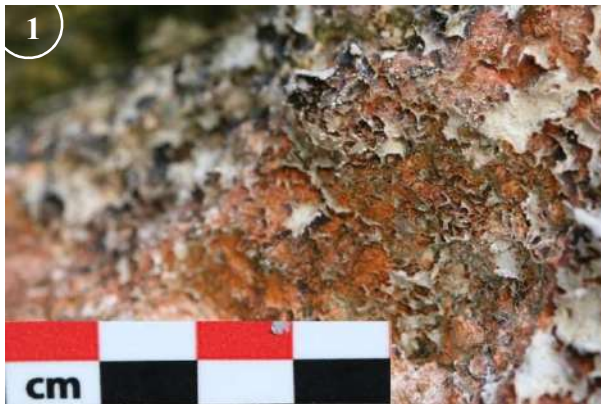
**Red-orange algae colonization:**

- This kind of biological colonization gives an orange- brown appearance to the stone surface.
- They flourish in stones that have continuous dampness. Even they can be recognized in summertime at some places at the castle.
- Their thickness on stone surface is not visible by the naked eye.

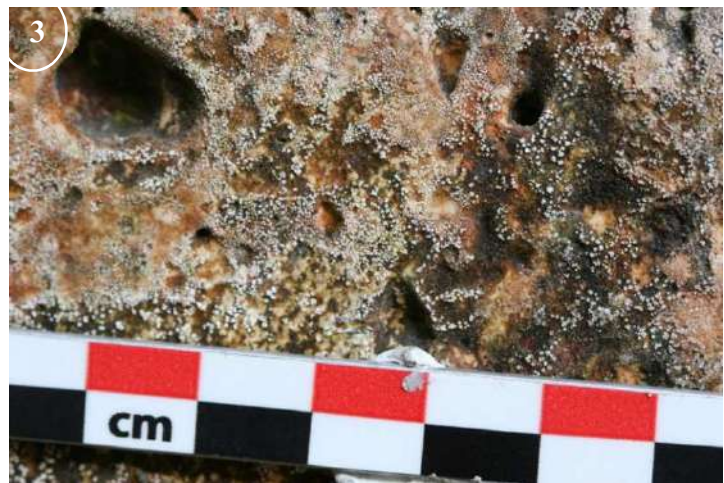
**Figure 8**

**Other species of biological colonisations:**

This kind of microorganisms can be found at Building (4) in northern pillars where the rainwater leaks from the roof.

The colonization is colored orange, green, and black. It forms a thin layer with a thickness of less than 0.5 mm, and that layer is peeled off from the stone surface in some areas, with a small amount of stone material attached to it.

from the stone surface in some areas, with a small amount of stone material attached to it. (Figure 4.2.7 & Appendix 1\_Figure 8). The second one can be found on the east face of the second pillar from west of the first northern row of Pillar of Building (4) (the same location as the B5 sample, see Appendix 3). That colonization is brown and has the appearance of moistened sand (Figure 4.2.8 & Appendix 1\_Figure 9).

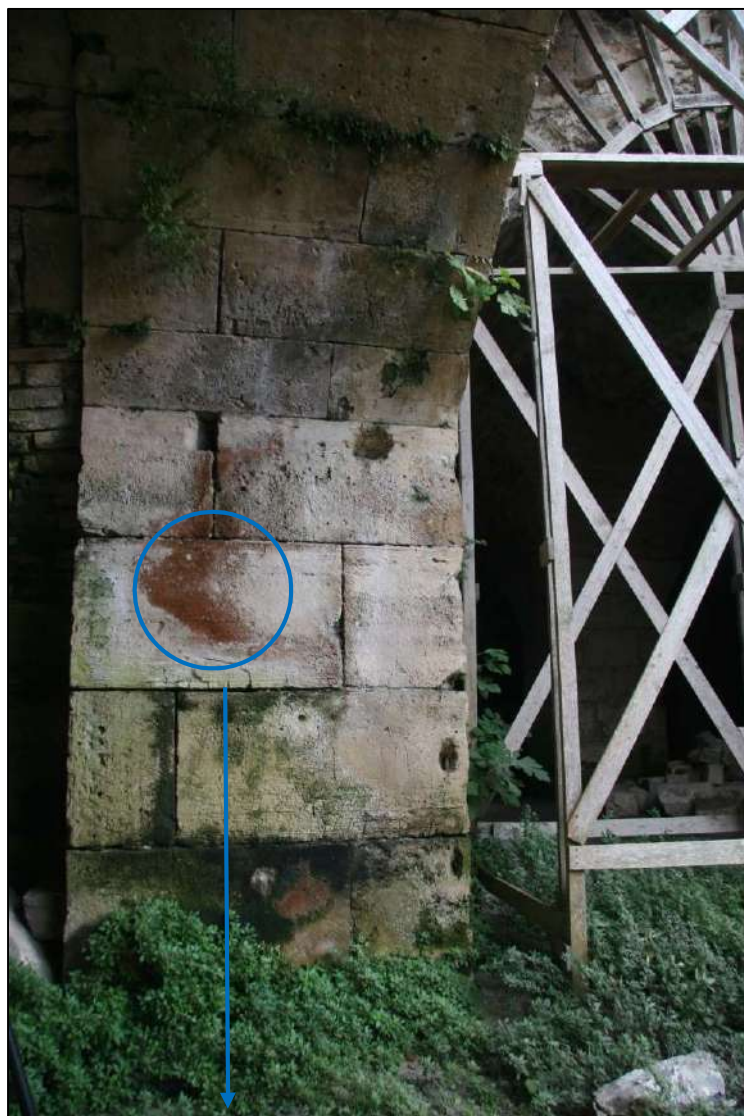
**Figure 9**

**Other species of biological colonisations:**

This kind of microorganisms can be found at Building (4) in northern pillars where the rainwater leaks from the roof.

The thickness of the colonization is about 0.5mm.

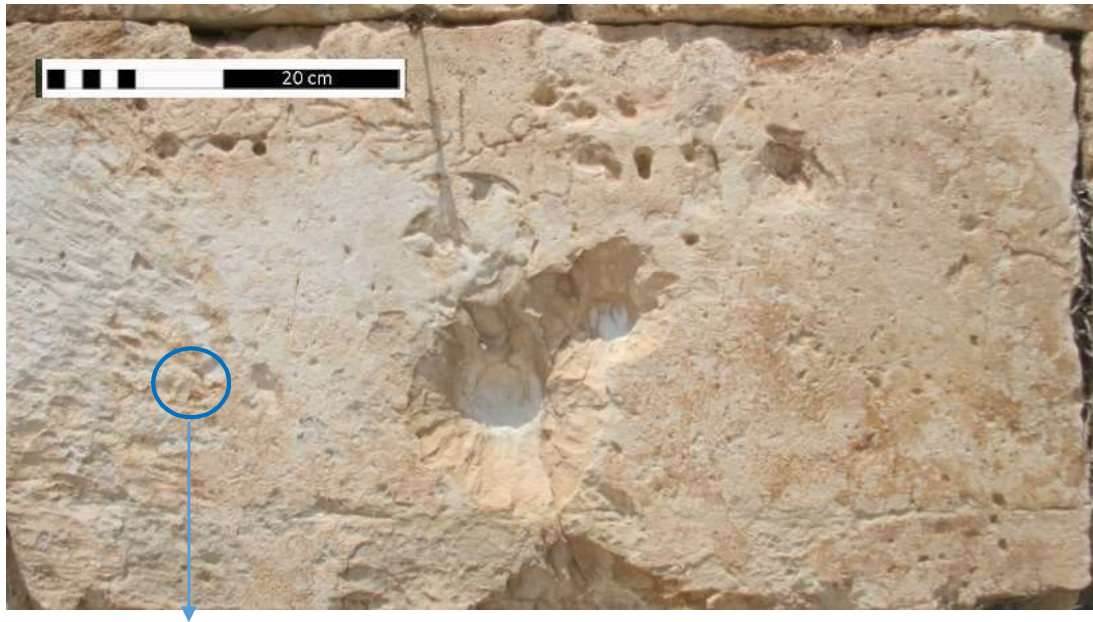
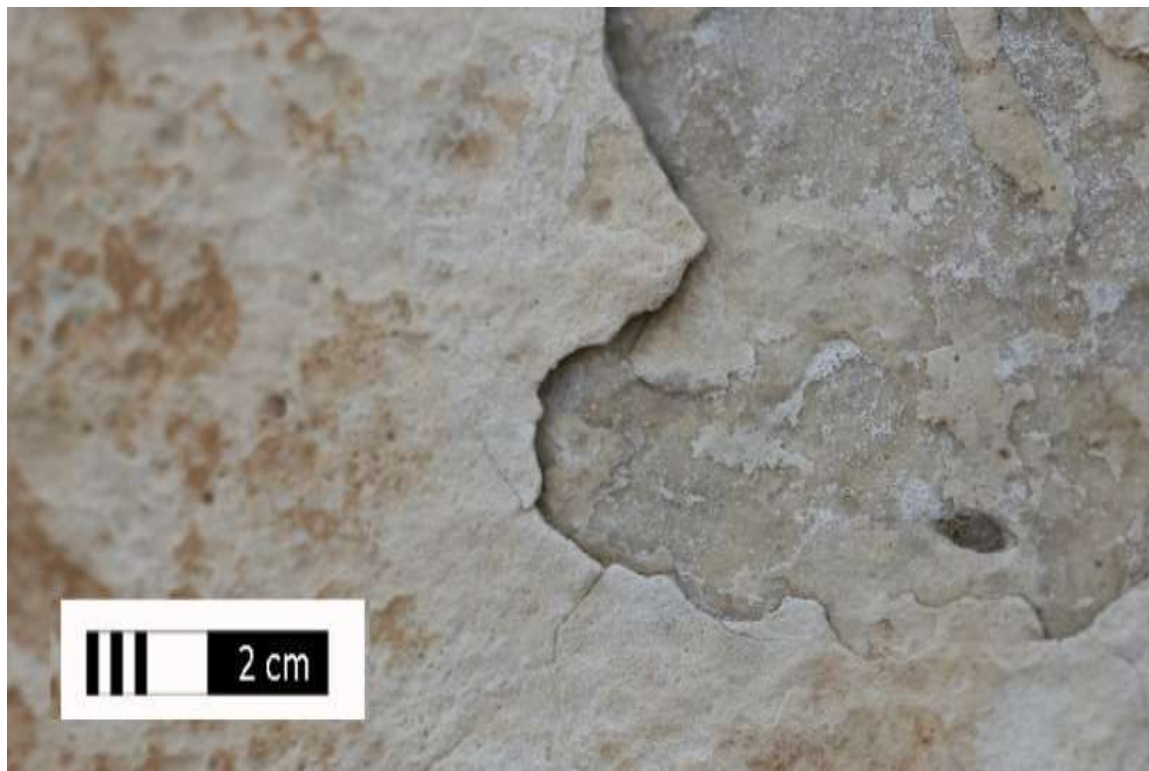
**Figure 12**

**Salt efflorescence:**

- The salts at the castle normally crystallize on the stone surface in very fine thickness (less than 0.5 mm).
- The salts layer can be distinguished at the stones that are located at both the external south and east façades.
- The white salts layer clearly appears at the discoloured stones with orange.

occurs by scaling with some traces of salt sub-efflorescence in some parts of the stone. The thickness of the exfoliated layer on the stone surface is about 0.5 cm, see Figure 4.2.16 & Appendix 1\_Figure 12.

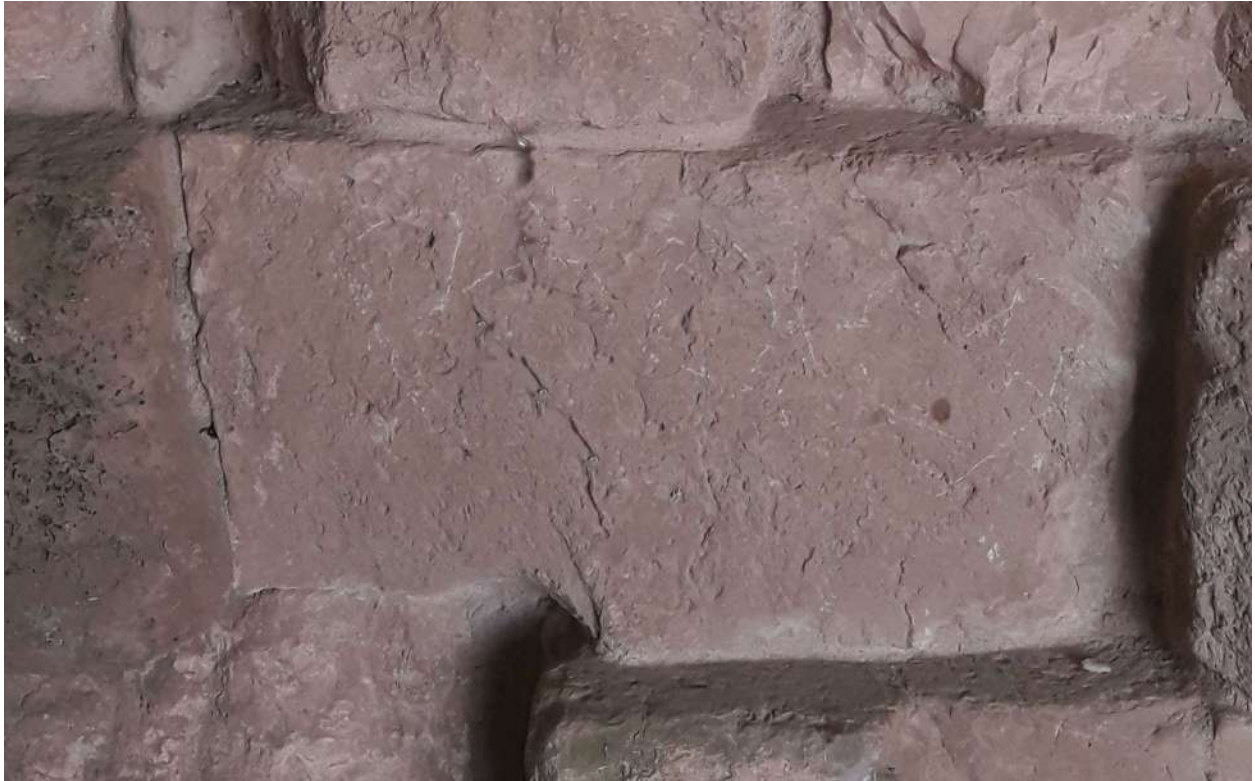
**Figure 15**

**Erosion:**

- The eroded stones characterised by smooth surface and rounded corners.
- The stone lost approximately 1 mm- 1 cm from its surface.
- This type of deterioration is a typical case in Building (35).

stones lost around 1 mm-1 cm from their surface (see Figure 4.2.21 & Appendix 1\_Figure 15). That building also contains stones with splitting parts that are fragmented and weakly attached to the mother stone. The sizes of splitting parts are variable (between 2- 10 cm in depth and 1-15 cm in width).

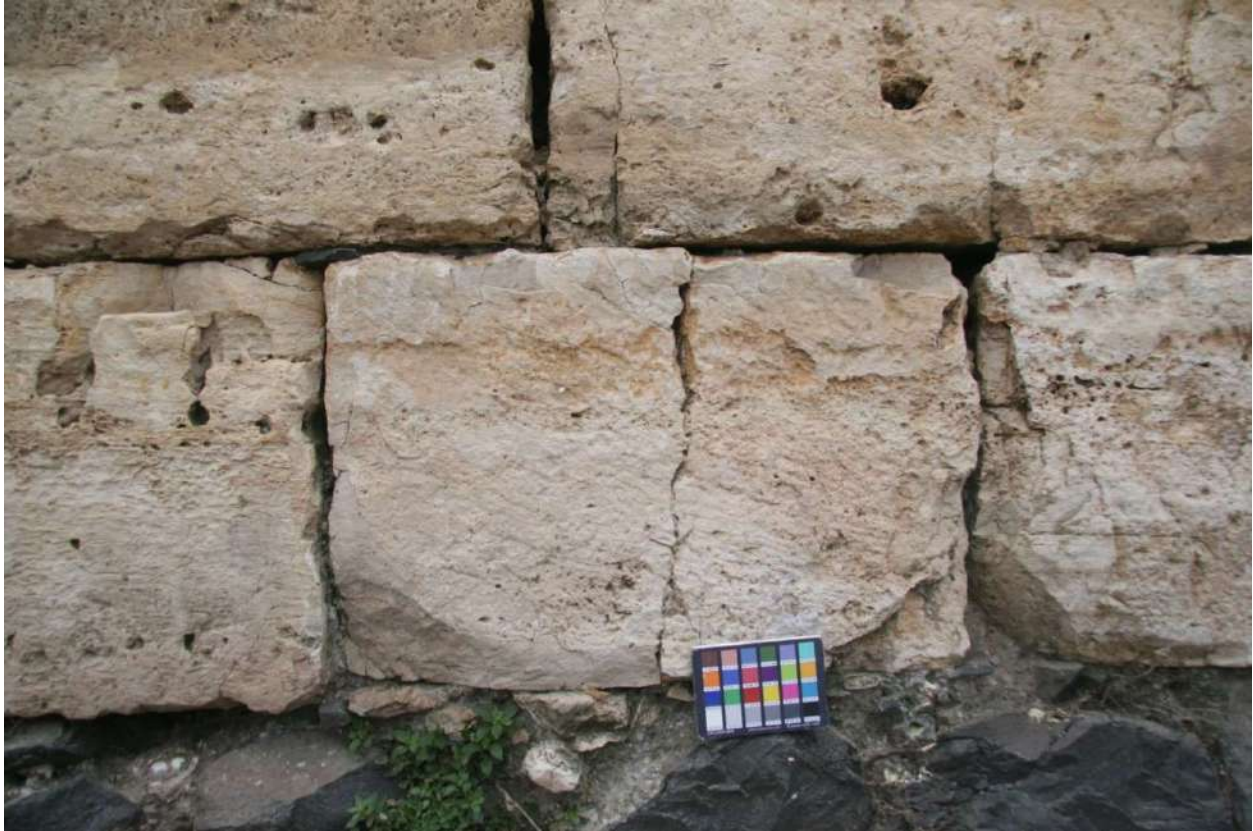
**Figure 16**

**Fracture:**

- Fracture divides the stone into two separated parts.
- The thickness of the fracture ranges 0.5 mm - 2 cm.

Cracks of different types can be also found at the castle. The first type of crack is a fracture that divides the stone into two parts. The thickness of the fracture ranges from 0-2 cm (Figure 4.2.17 & Appendix 1\_Figure 16).

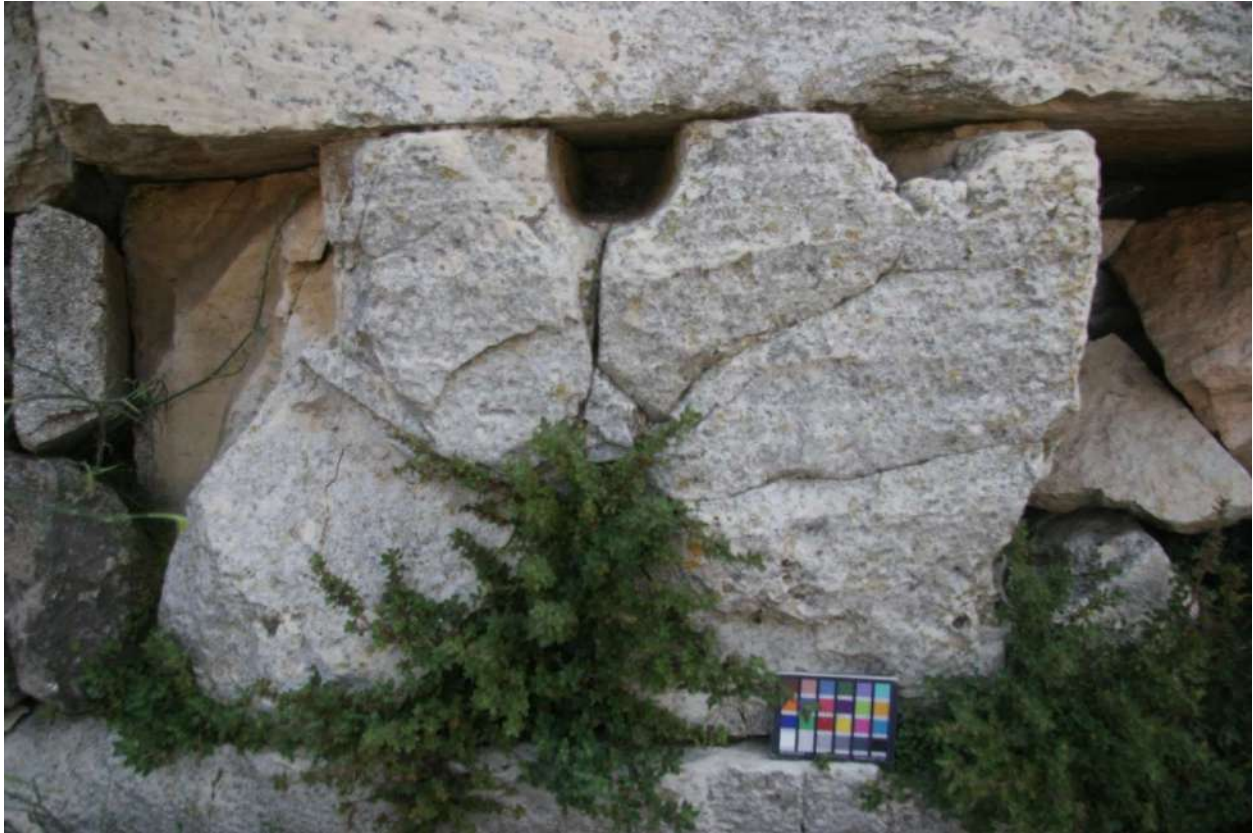
**Figure 17**

**Star crack:**

- It is a network of cracks that are originated from one point (centre).
- The thickness of each crack is around 0.5- 10 mm.
- That point is created by mechanical damage that might be resulted from bombing effect or growth of higher plant.

plants (Figure 4.2.18 & Appendix 1\_Figure 17). Hair and minor cracks can also be found on some stones in the castle. The bombing effect does not cause those cracks, however many of them existed before the war. The sizes range from 0.5 mm to 2 cm and they do not cause separation of the stone parts (Figure 4.2.19 & Appendix 1\_Figure 18).

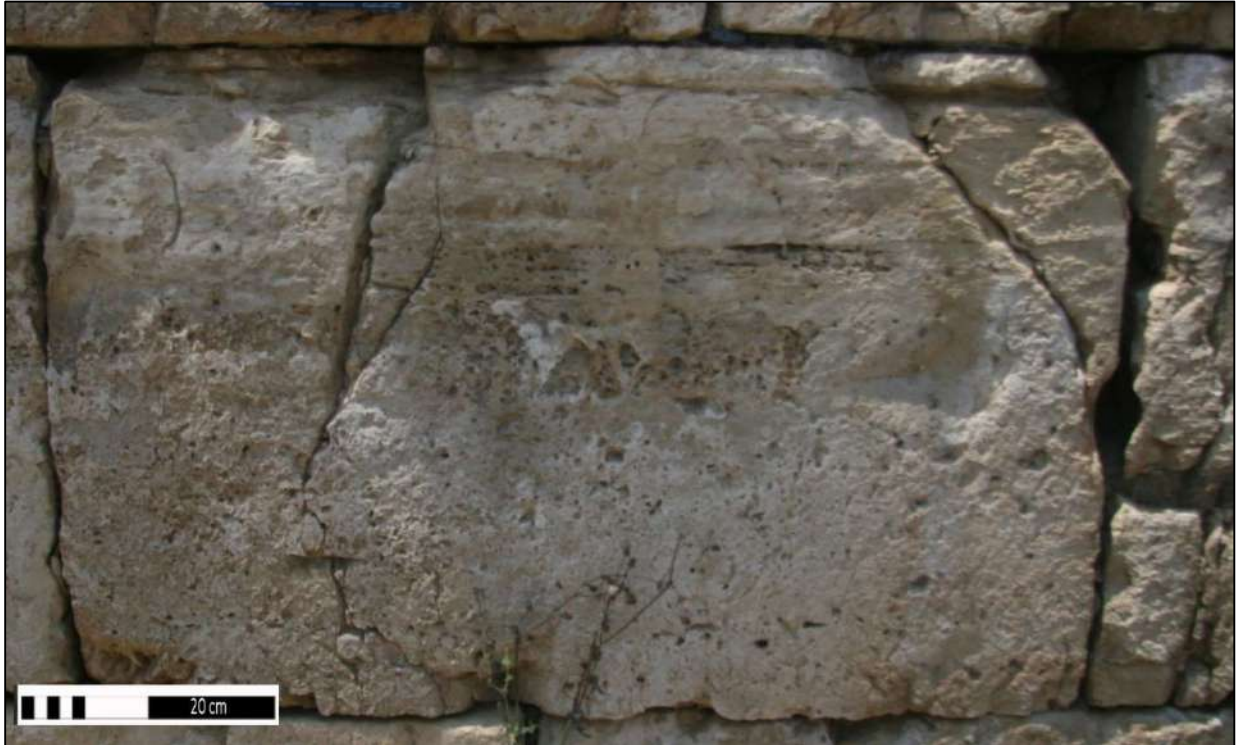
**Figure 18**

Hair and minor crack:

- The sizes of these cracks range 0.5 mm to 2 cm.
- The cracks and fissures are not caused only by missiles and exploding effects, whereas some of them have existed before the war.
- These type of cracks do not cause separation of the of stone parts.

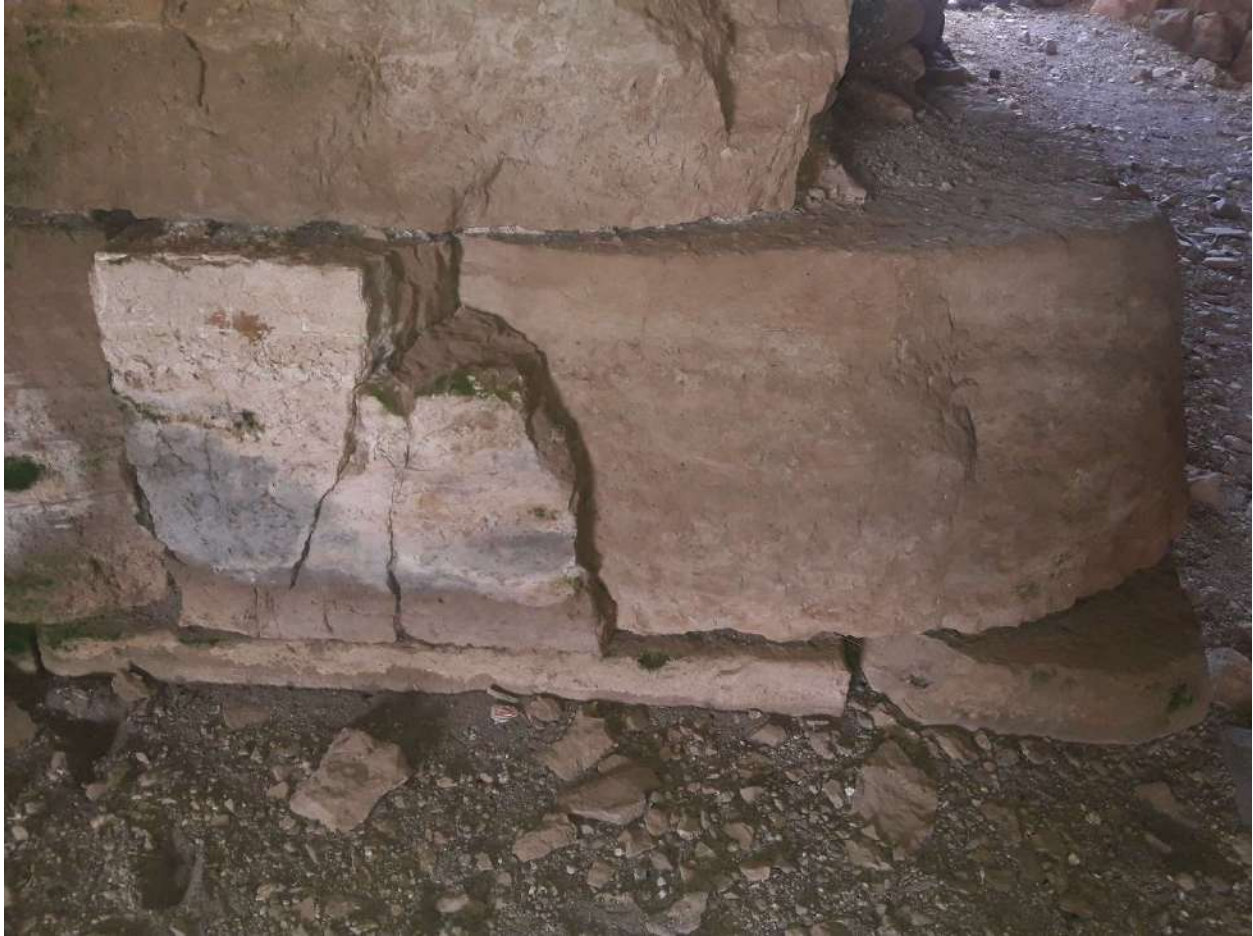
**Figure 19**

Splitting:

- Those parts are fragmented and weakly attached to the mother stone.
- The sizes of splitting parts are variable (between 2- 10 cm in depth and 1-15 cm in wide).
- In some stone, splitting parts appear in white and grey colours.
- This case found is typical in building (35).

In some stones, splitting parts appear in white and grey colours (see, Figure 4.2.22 & Appendix 1\_Figure 19).

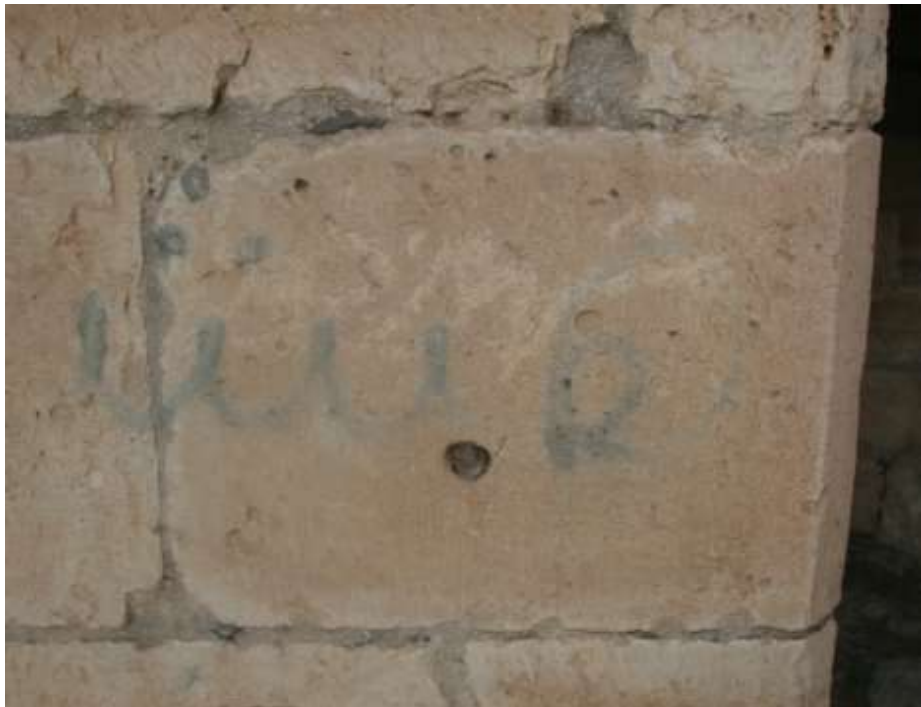
Figure 20

Graffiti:

- Paint marker pen or sharp tools were used for writing.

Graffiti is widespread on the stones at the castle, where paint marker pen or sharp tools were used for writing (see, Figure 4.2.20 & Appendix 1\_Figure 20).

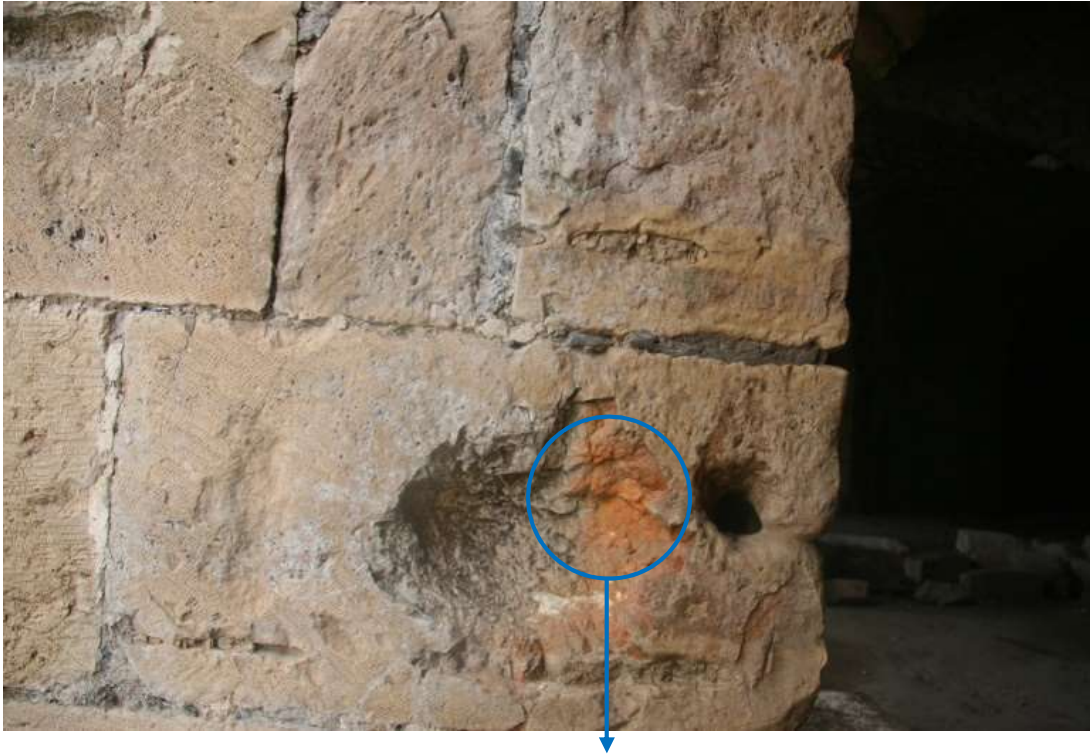
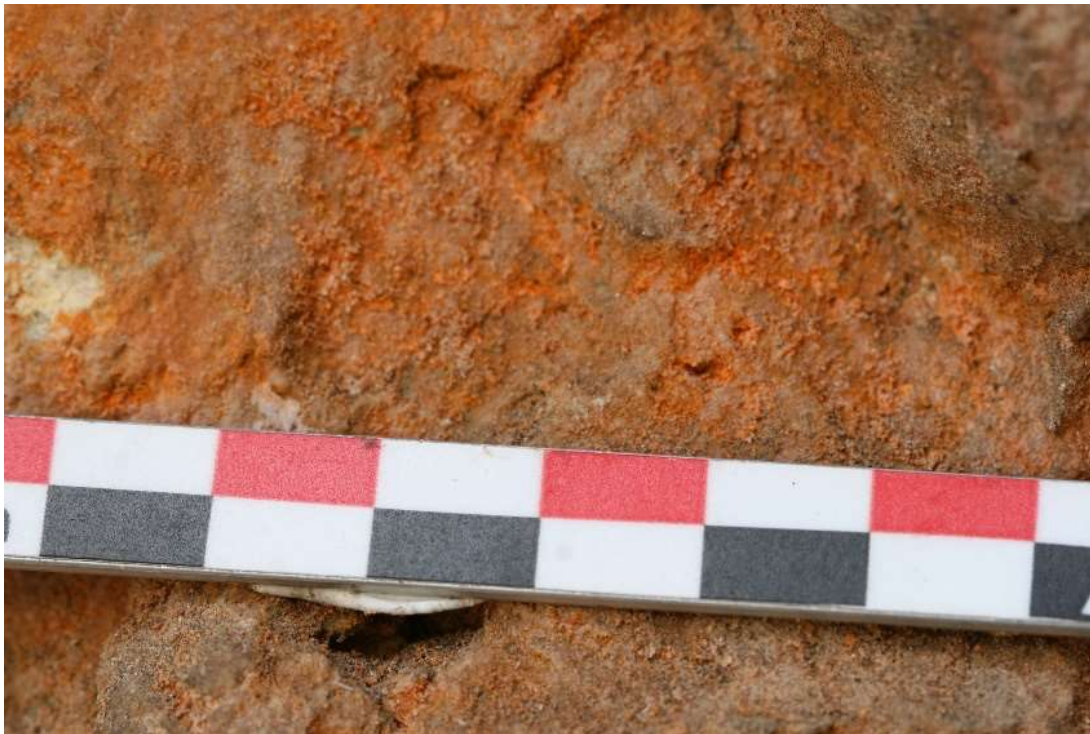
**Figure 21**

**Deposition of orange material**

- In sheltered stones, this orange material concentrates on areas which exposed to shut bullets.
- This material can be removed easily by hand.

- In both Building (19) and Building (23), some sheltered stones were exposed to bullet or missile fragments. On the damaged areas of these stones an orange material deposits weakly on the stone surface (see, Figure 4.2.23 & Appendix 1\_Figure 21).

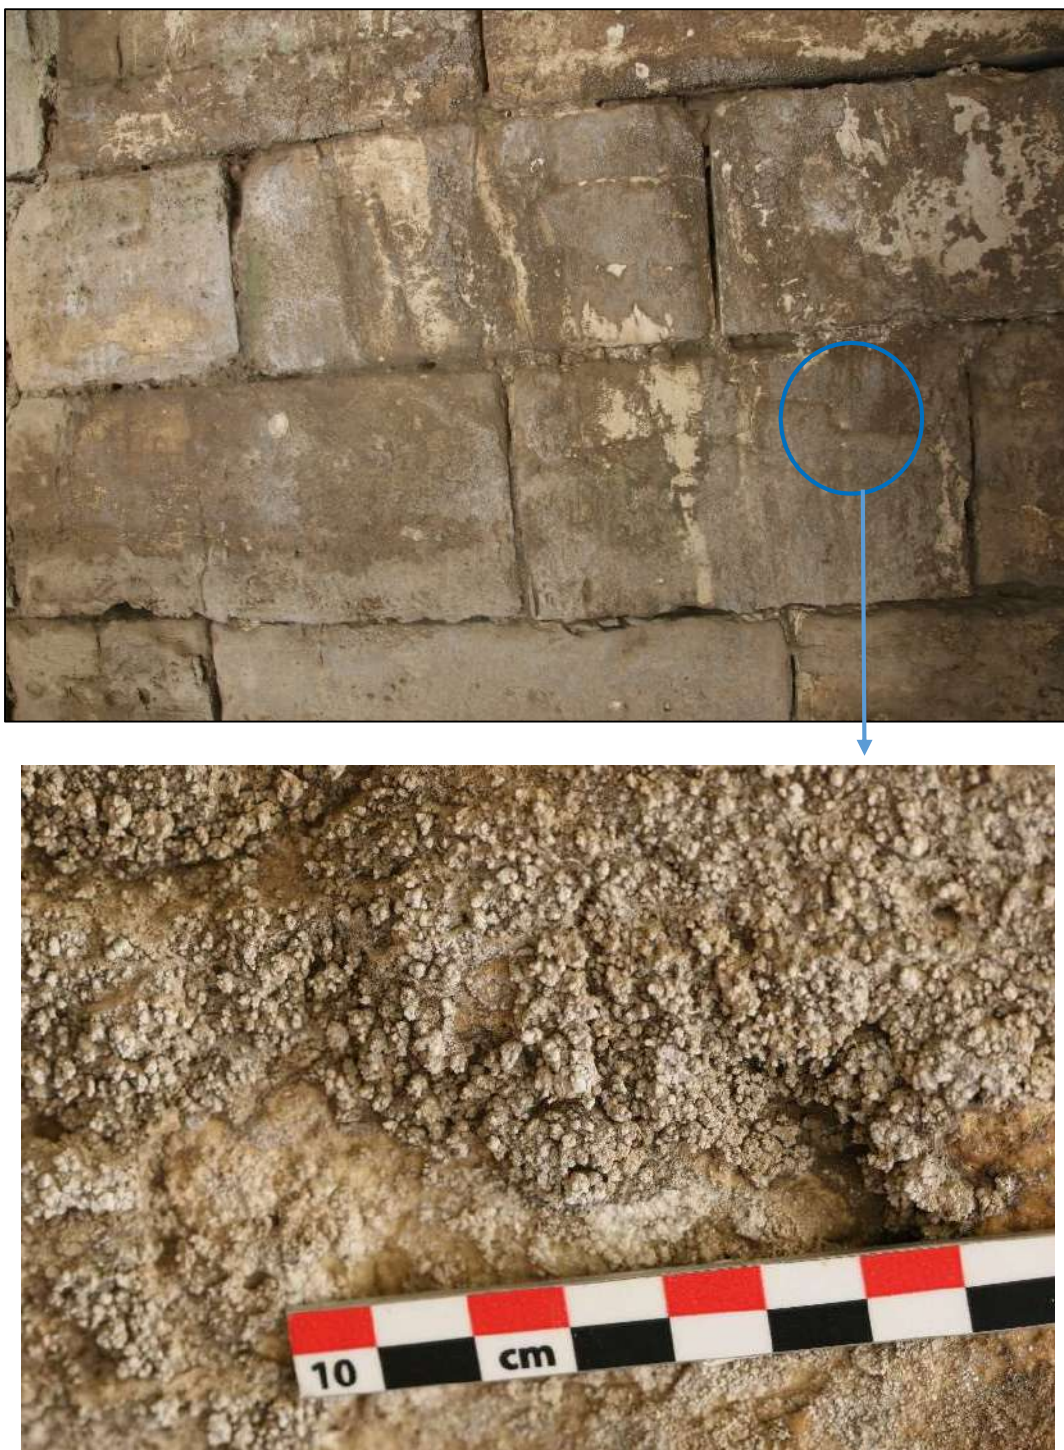
Figure 22

**Encrustation:**

- On the northern and eastern internal façades of Building (38), rounded material deposits heavily on the stone surfaces (encrustation). This framboidal crust adheres to the stone firmly. Each round is 2-5 mm in diameter. (see, Figure 4.2.24 & Appendix 1\_Figure 22).

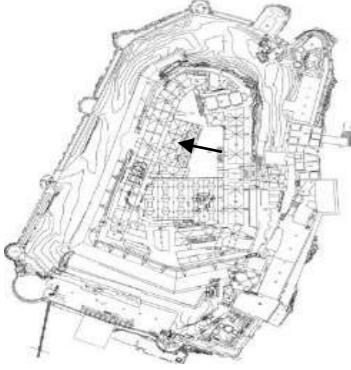
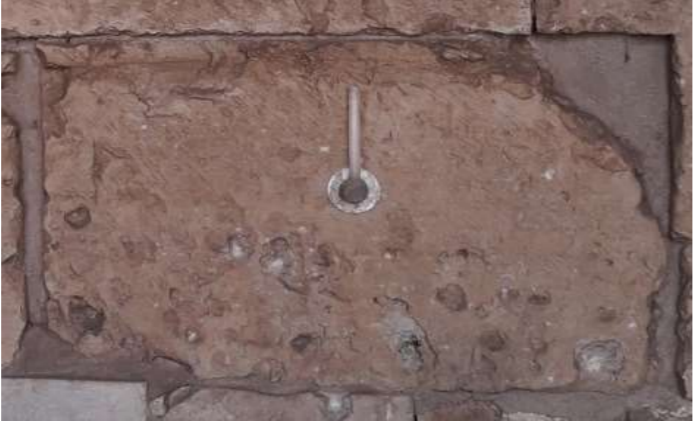
HDS_0

33	27.5	48.0	39.5	5.4

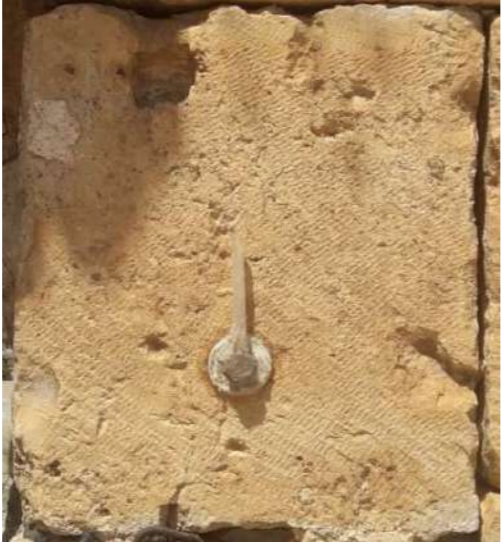
HDS_D_1

27	27.5	48.0	36.4	4.9

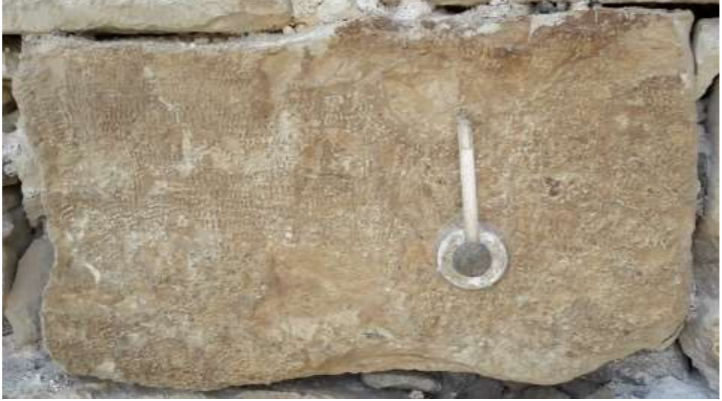
HDS_D_2

29	24.4	45.9	32.6	4.8

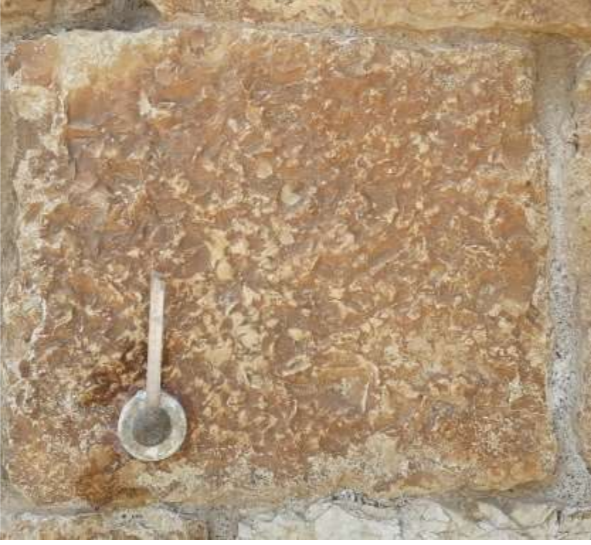
HDS_D_3	_____	31	31.5	64.5	48.5	8.9

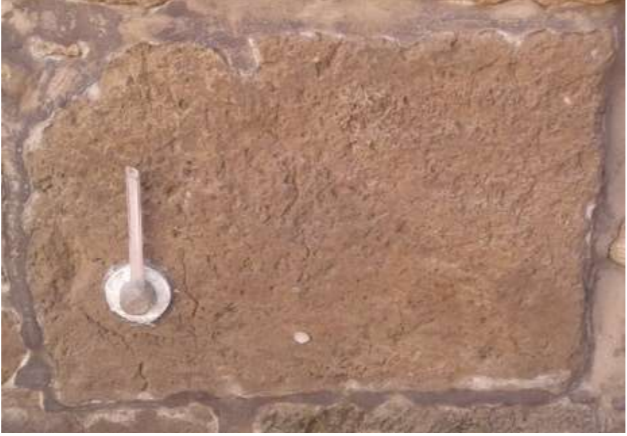
HDS_D_4	_____	25	14	30	20.6	4.2

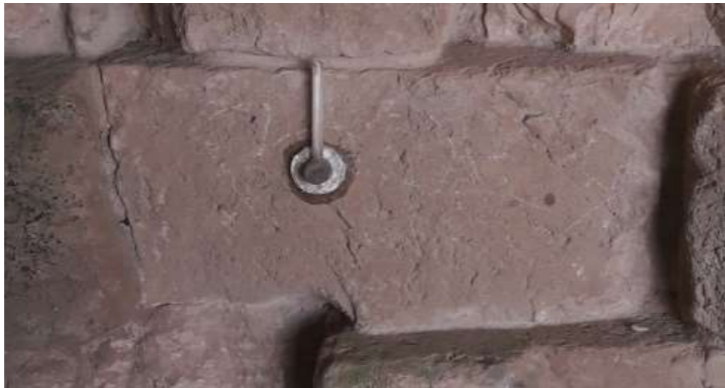
HDS_E

19	19.4	31.5	24.7	4

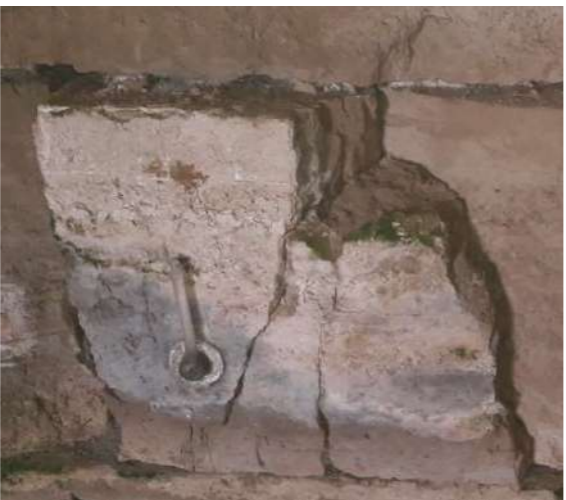
HDS_EF

27	18.8	39.7	27.7	5.4

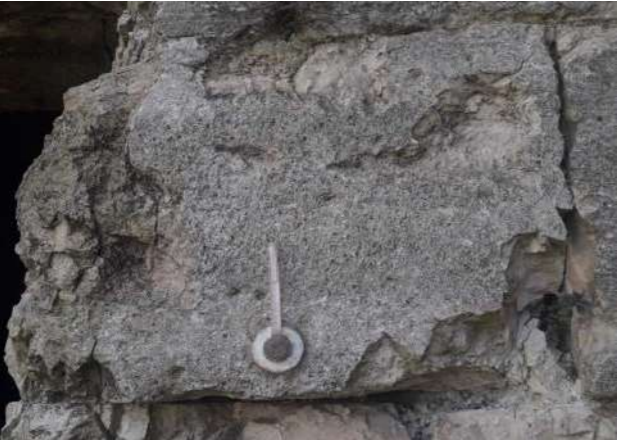
HDS_FMC

20	16.8	48.0	32.5	10.8

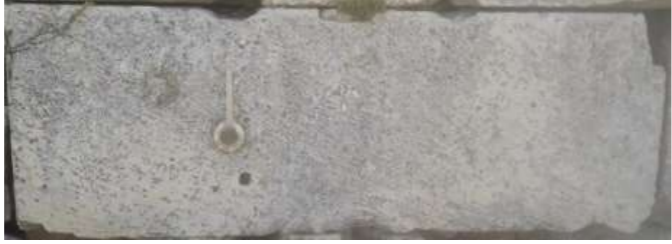
HDS_MC_1	_____	38	39.7	56.2	45.8	4

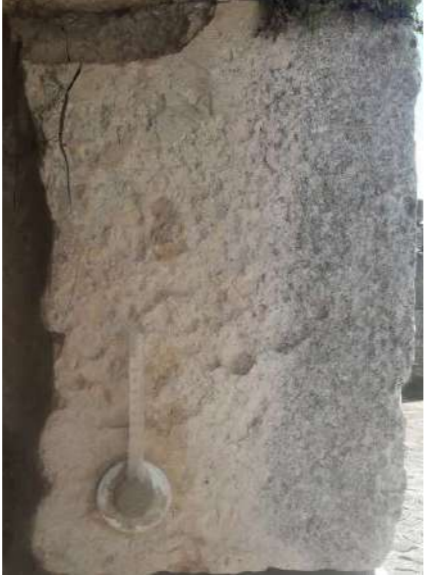
HDS_MC_2	_____	23	37.7	56.2	45.3	4.8

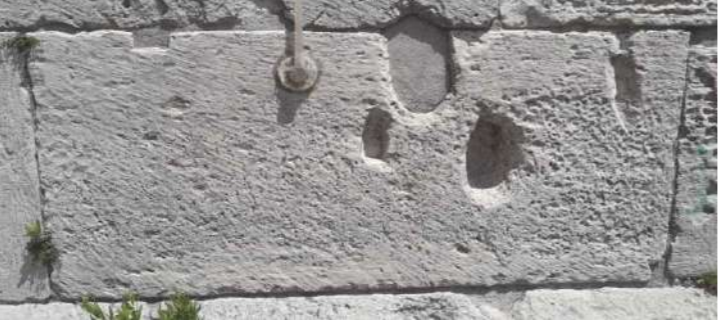
HDS_MC_3	_____	31	27.4	50.0	37.8	4.9

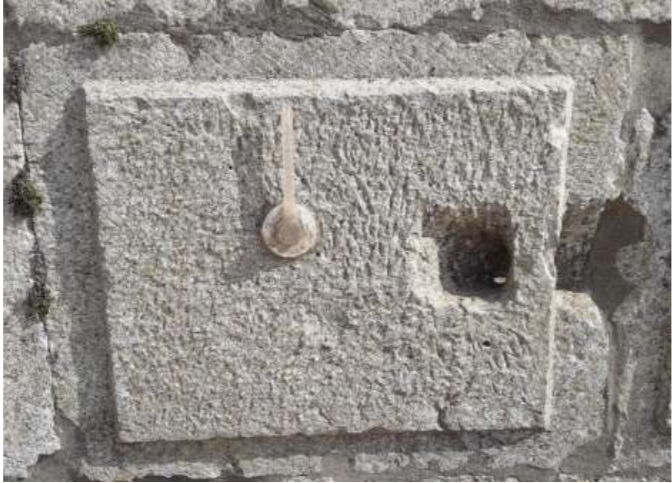
HDS_MC_4	_____	31	41.8	52.1	46.8	2.7

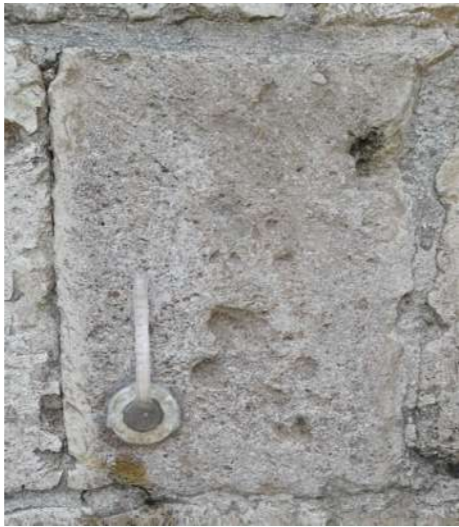
HDS_MC_5	_____	29	27.5	50	41	6.1

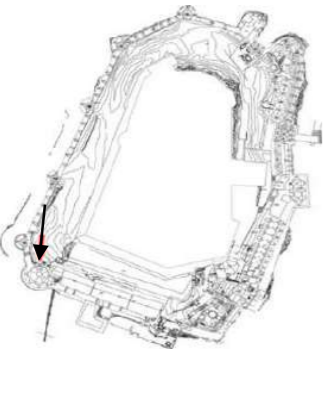
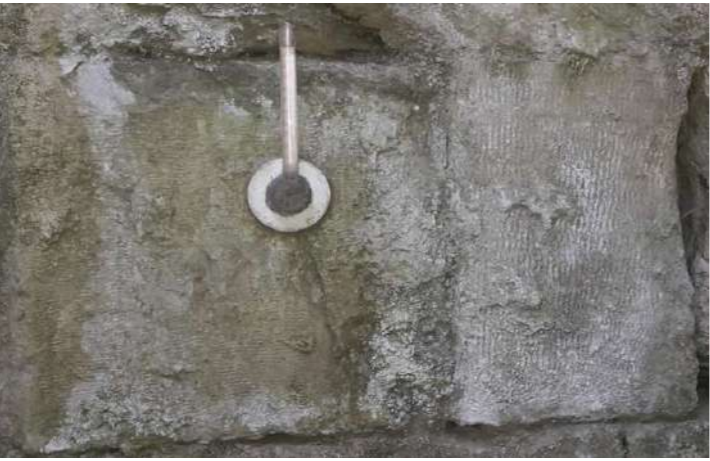
HDS_MC_6	_____	29	34.1	56.3	47.5	6.1

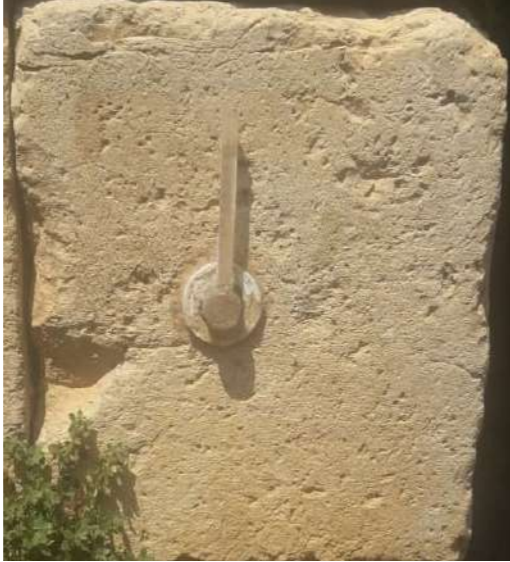
HDS_DS	_____	23	41.8	52.1	47.9	2.4

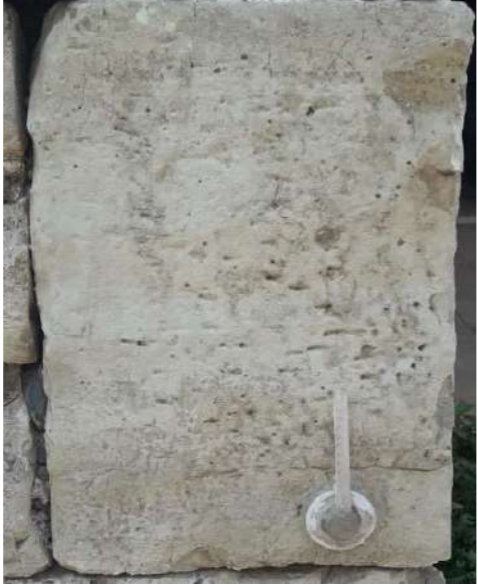
HDS_S	_____	28	28	49	40.6	1.6
