Thesis

PhD

Diagnosis and Analysis of Monument Deterioration Classification and Investigation

Study Case: The Medieval Fortifications of Syria/ Crac Des Chevaliers/

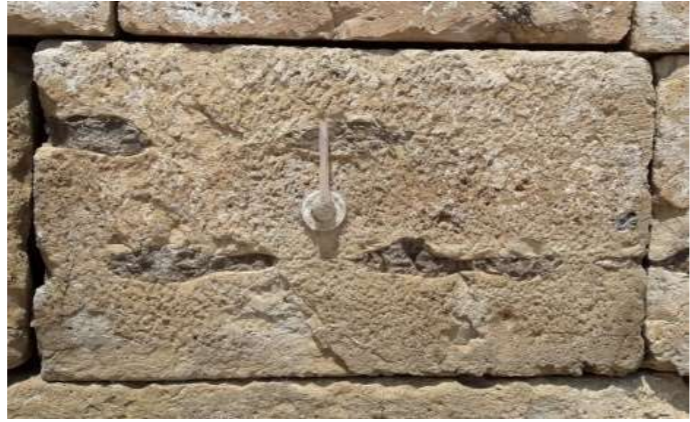
LS_S_1

42	25.4	46.9	34.9	4.6

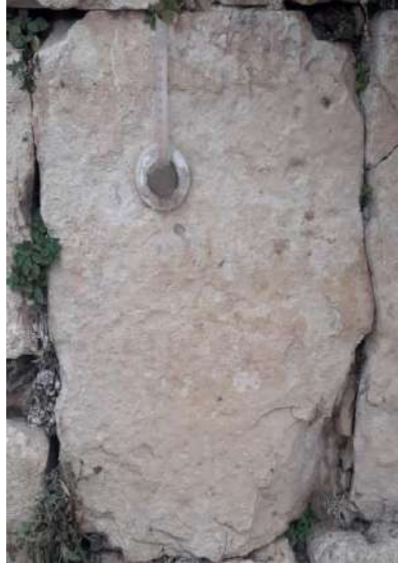
LS_S_2

28	30	46	38.6	4.6

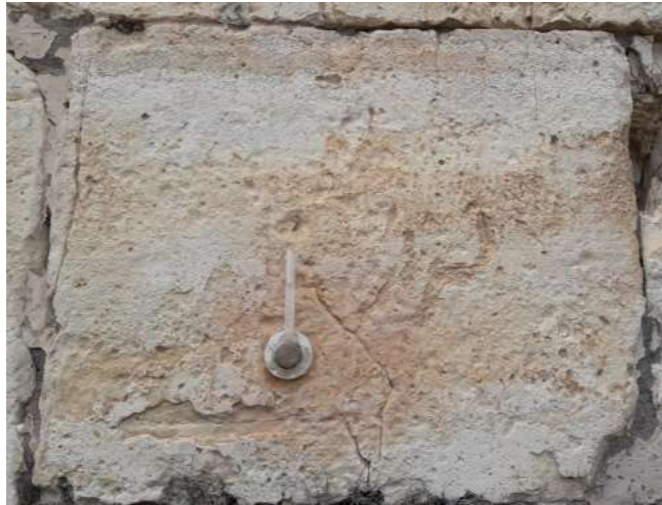
LS_D

42	35.6	54.2	42.2	4.4

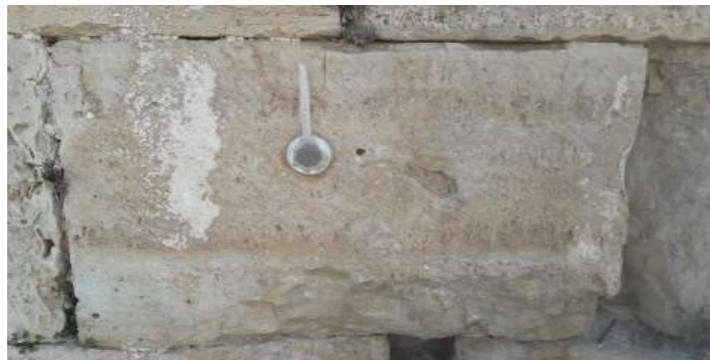
LS_DS

30	34.5	61.0	46.8	5.5

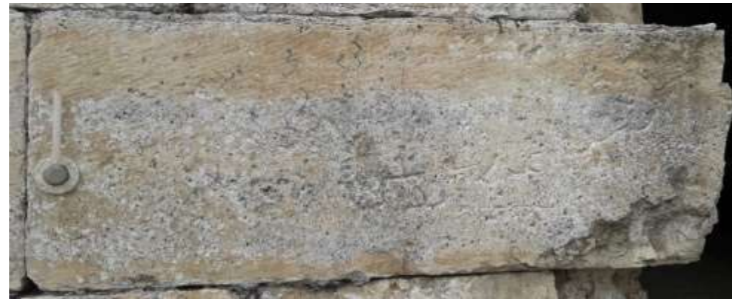
LS_MC_1

43	27.5	56.2	41.3	5.3

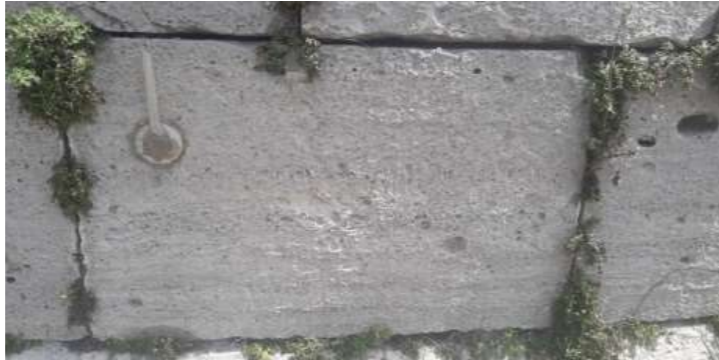
LS_MC_2

40.0	31.5	56.2	44.4	5.2

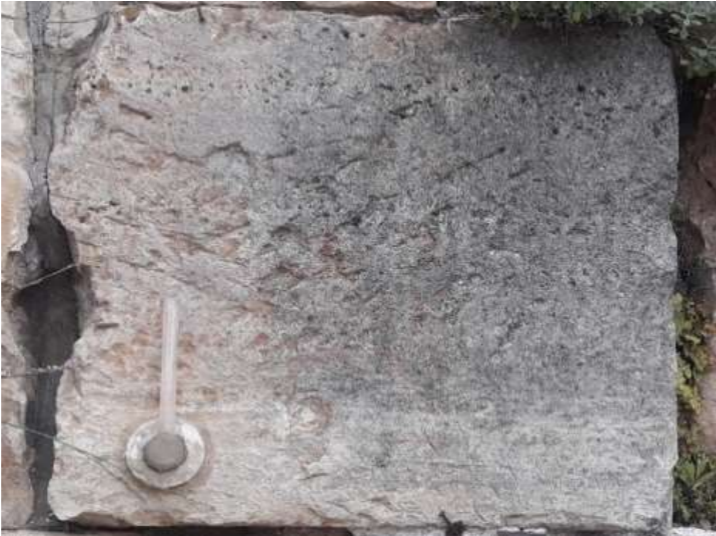
LS_MC_3

38	35.6	54.2	43.6	3.9

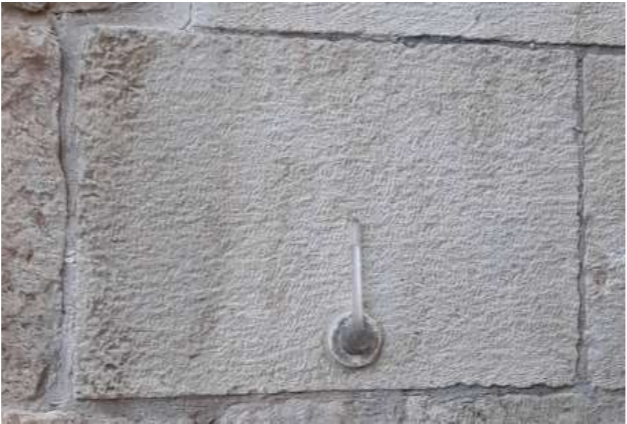
NBS_0_1

26	33.6	45.9	38.1	3.4

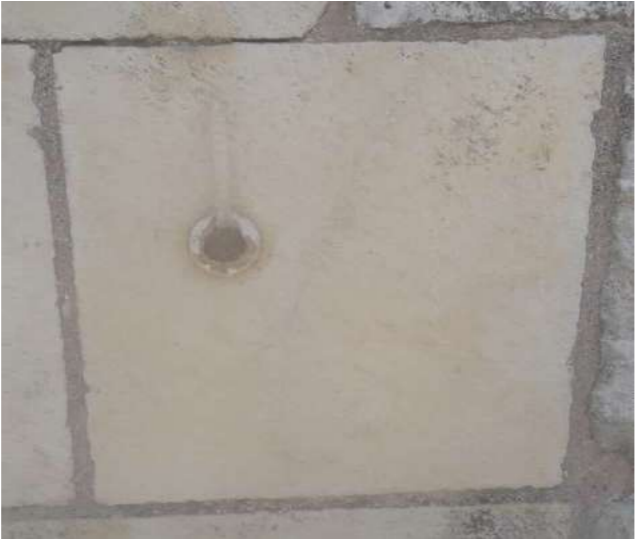
NBS_0_2

23	35.6	53.1	42.6	4.9

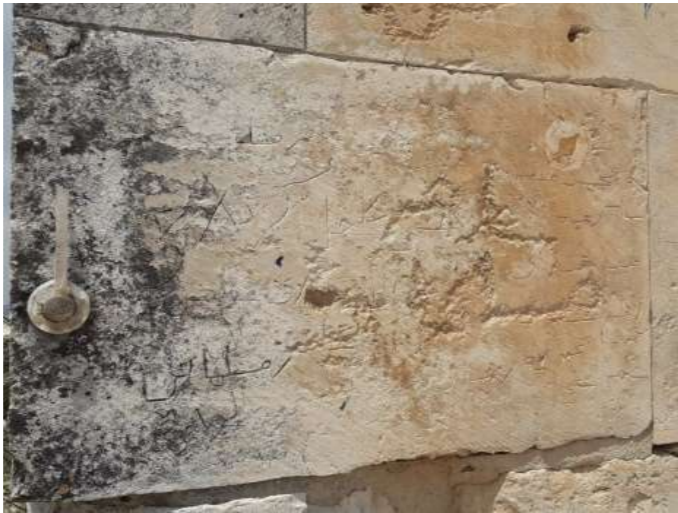
NBS_MC

28	33.6	50	42.4	4.6

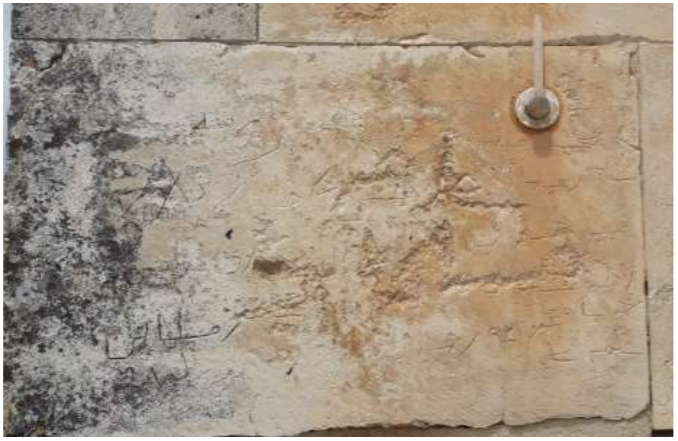
NBS_D

28	33.6	50	42.4	4.6

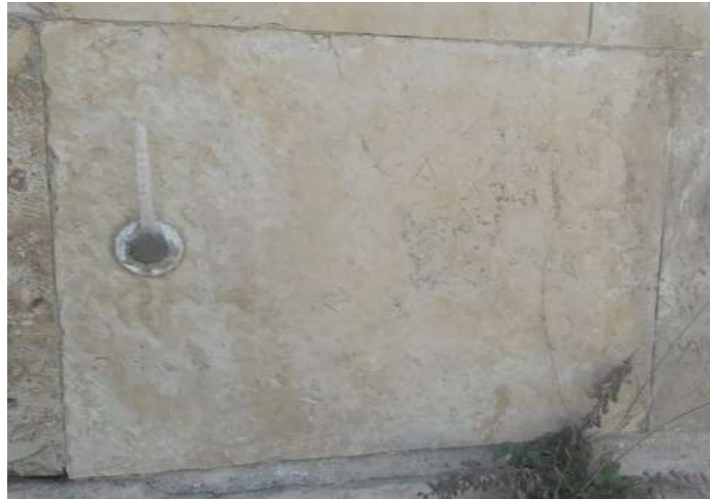
NBS_S

29	31.5	51.1	40.5	4.4
